CRYSTAL RIVER, SEGMENT 1

Beaver Lake above Marble to the Base of McClure Pass

6.13.1 Crystal River Segment 1

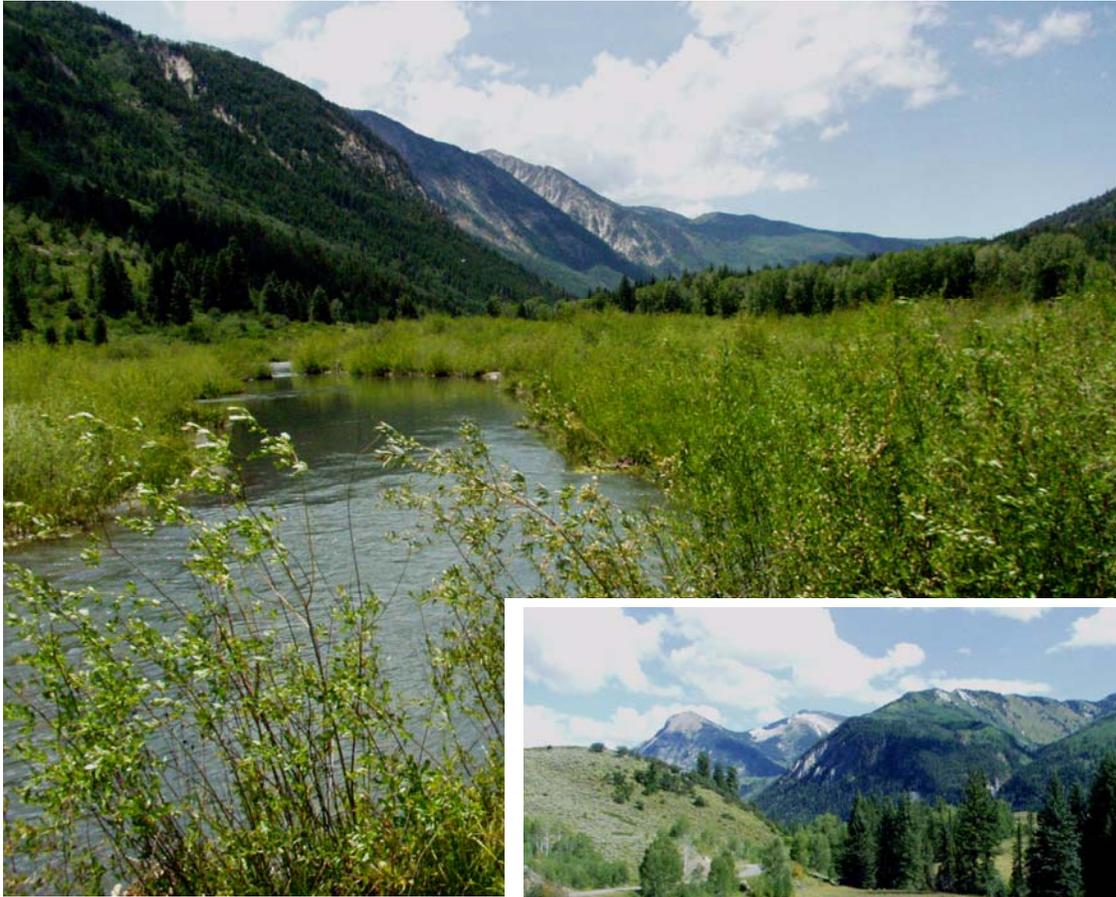
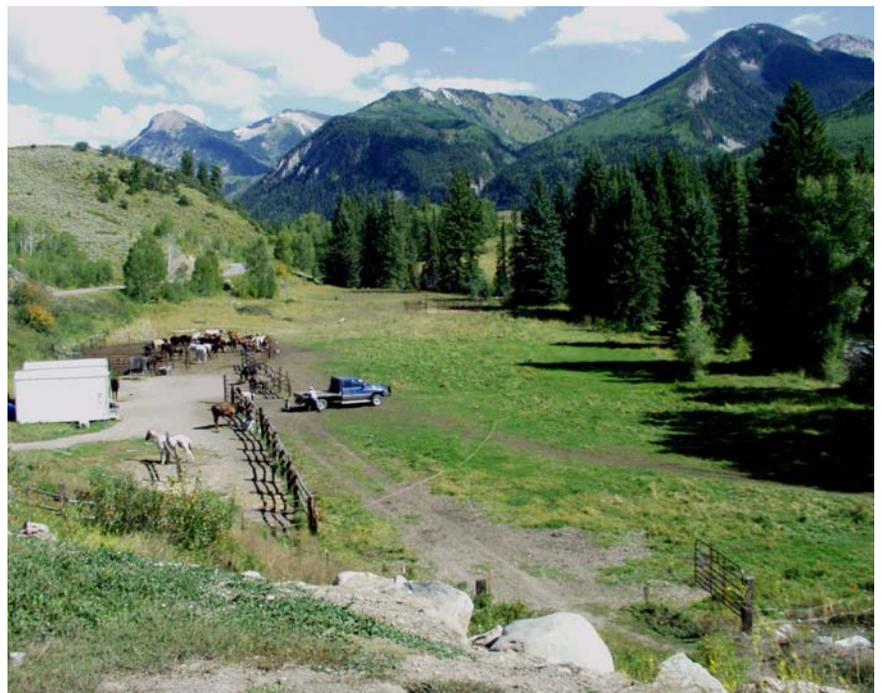
Development and recreational pressure threaten stream sustainability. In the photo above beaver activity has created a high quality wetland near the Town of Marble. In the photo below a recreational horse riding operation has resulted in elimination of most of the native riparian vegetation.

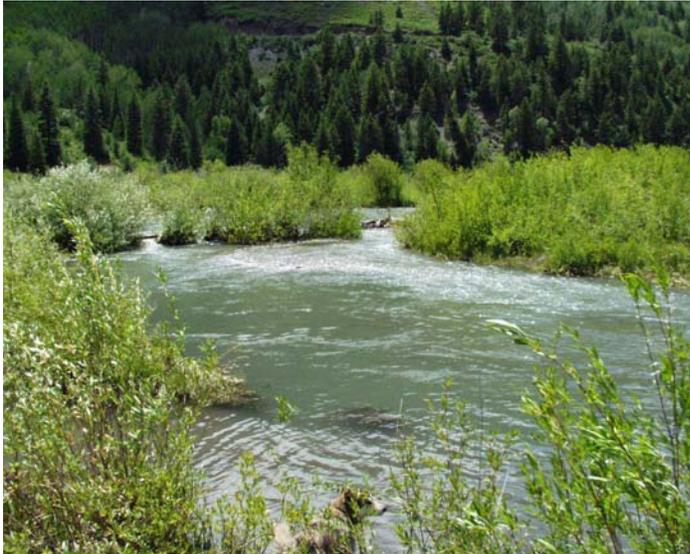
CR1-1: At the top of the reach where Yule Creek has its confluence with the Crystal River a large willow carr is sustained by beaver activity. The beaver-willow ecosystem has been essential to stream restoration. This habitat provides excellent songbird breeding habitat and very high wildlife potential. Uncontrolled recreation threatens riparian and stream wildlife values. Appropriately located trails should be identified and hardened; social trails should be closed and revegetated; cars should be prohibited from driving on stream banks; and educational signage should be installed.

Above: At CR1-1 spring floods recharge the willow carr.

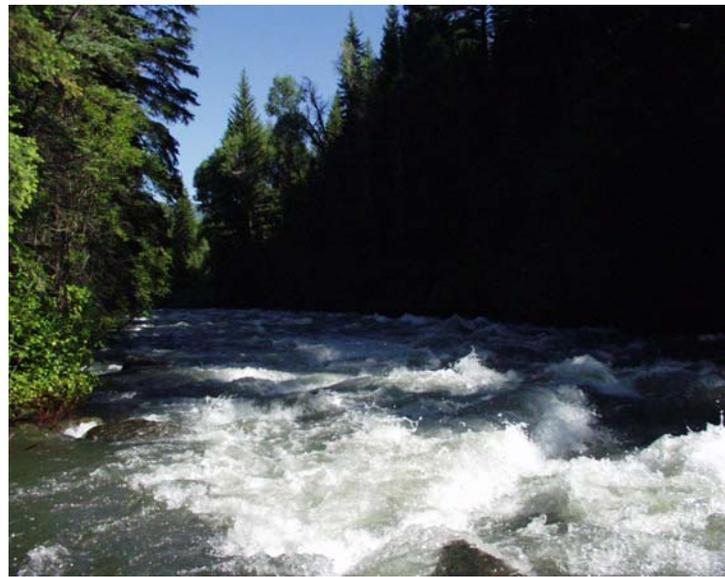
CR1-3: The stream runs through a steep canyon in this reach. Riparian and stream habitat are in very good condition and provide high wildlife potential. Uncontrolled recreation threatens riparian, stream and wildlife values. The downstream end of this reach abuts with a developed campground which is a source of disturbance. This campground, which is currently used only for “group events” should be closed and revegetated. Social trails should be closed and revegetated.

Right: At CR1-3 flooding flows are dissipated by large boulders. Dense riparian vegetation protects stream banks from erosion even during high flows.

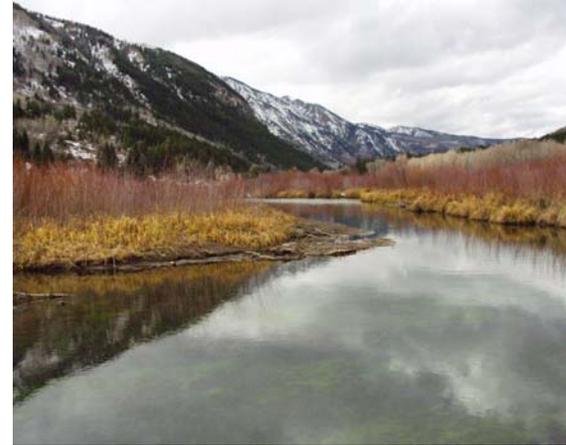
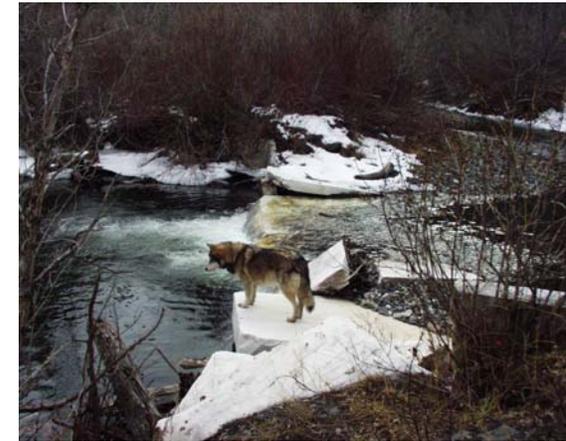
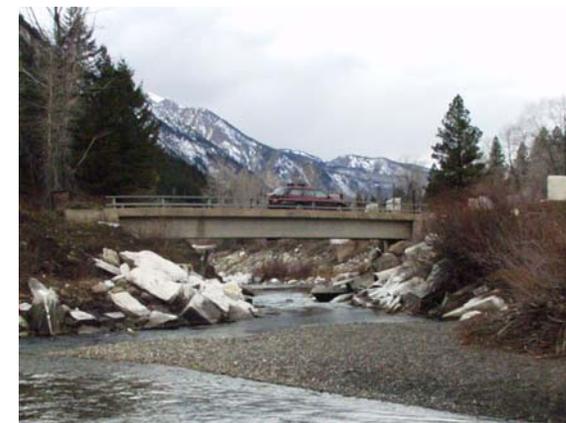
Above: Beaver activity has created a wide willow carr that helps stabilize the stream.
Middle: Marble riprap was used to stabilize banks at the confluence of Yule Creek and the Crystal River.
Below: Historic stream and bank degradation continue to affect stream functions.

- Restore riprapped stream banks; remove riprap and revegetate with soil-moisture-appropriate native plant species.
- Revegetate levee at Beaver Lake with native riparian plant species.
- Enhance the hydrologic connection between Beaver Lake and the Crystal River
- Close and revegetate social trails that emanate from the recreation area at Beaver Lake
- Designate and harden an appropriately located recreational trail.
- Install educational signage regarding the importance of staying on the designated trail.
- Establish appropriate development setbacks that include prohibitions regarding riparian vegetation removal.

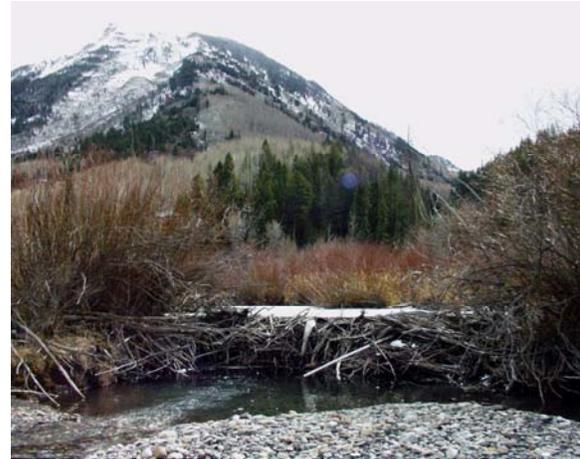
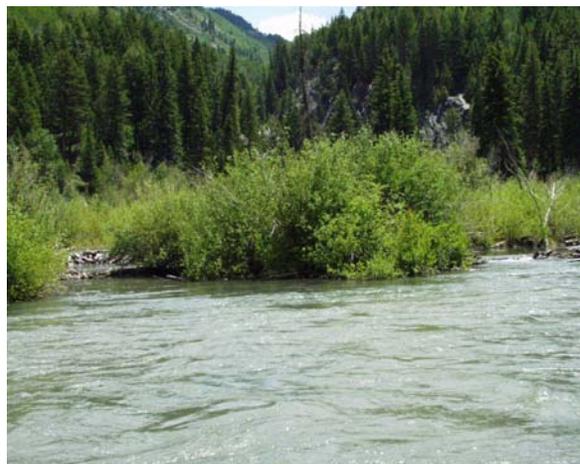
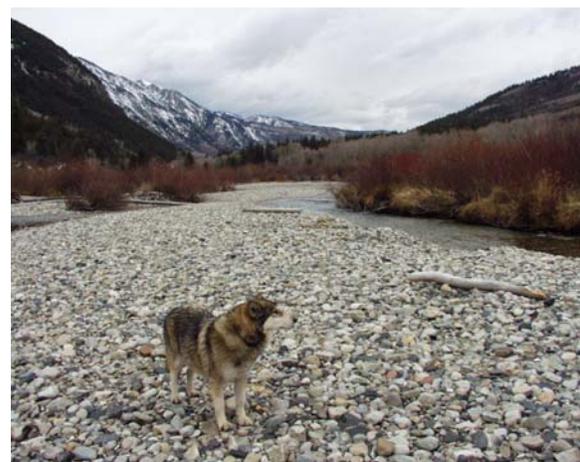
Above: Beaver dams store water and create conditions that enable willow carrs to thrive. Mid: Dense vegetation protects banks from erosion during spring flood. Below: Excess bedload is deposited and braids the stream channel.

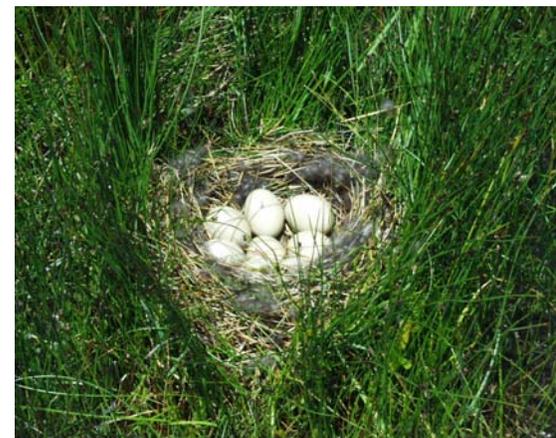
Blue-winged teal eggs; Willow carr habitat provides excellent potential for a large variety of wildlife. Human trampling can undermine habitat potential and be devastating to nesting birds and mammals.

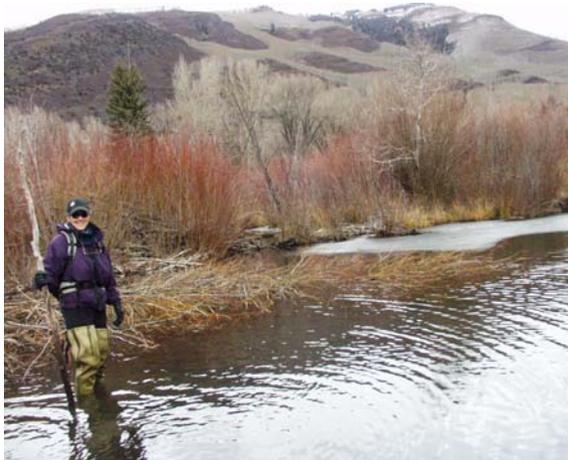
Left: Even during low-flow season, in beaver ponds water is plentiful; Janis is standing in front of the beaver's winter cache of willow stems.

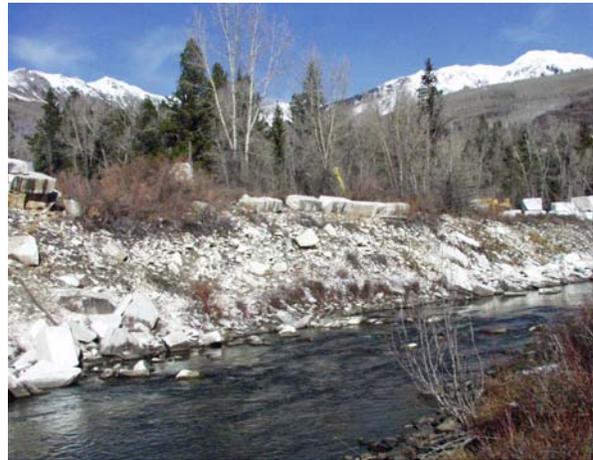
Right: Stream banks adjacent to the marble mill site have still not recovered from historic degradation.

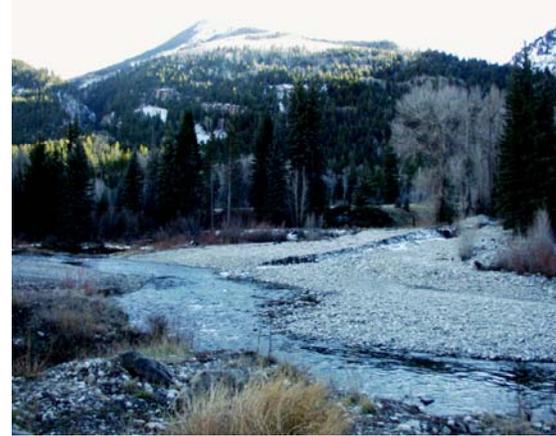
Above: Large deposits of cobble braid the stream channel.

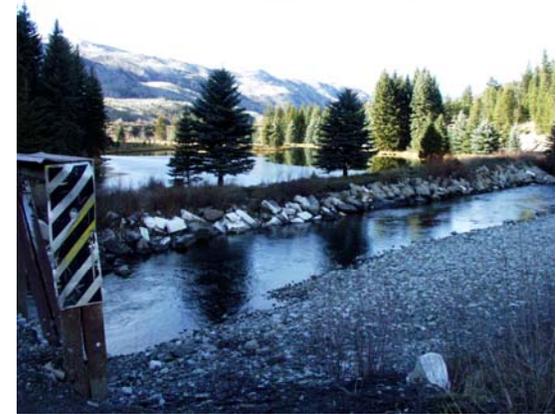
Middle: Stream straightening and riprapped banks eliminate wildlife habitat.

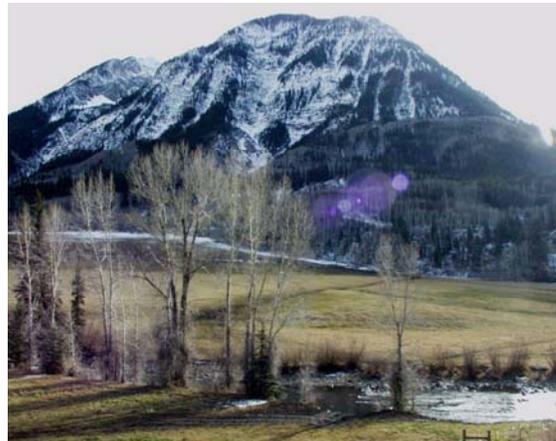
Below: Riparian habitat has been removed and replaced with pastures.

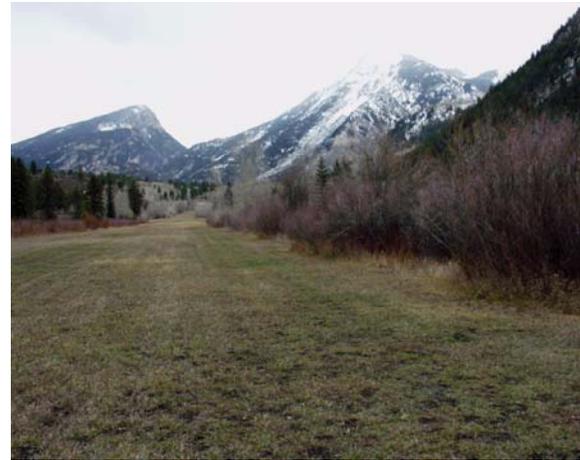
Above: The riparian zone has been cleared and replaced with a grass landing strip.

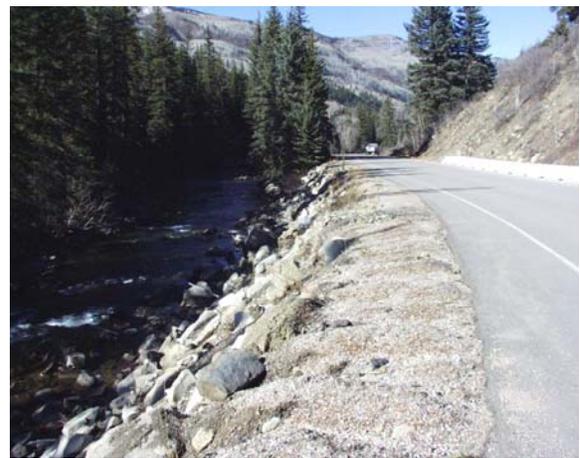
Middle: Road-based gravel and sediment washes directly into the stream

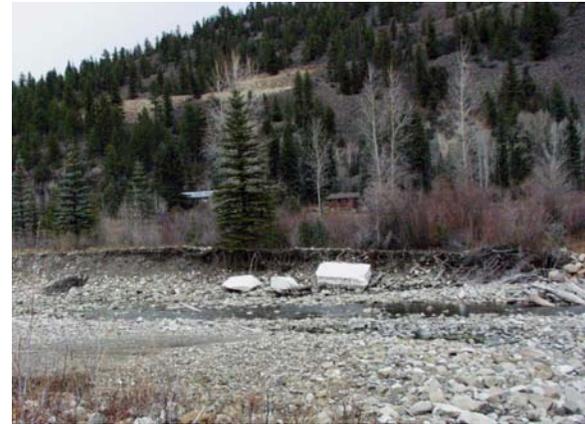
Above: The stream is widening, shallowing and braiding due to bank instability.

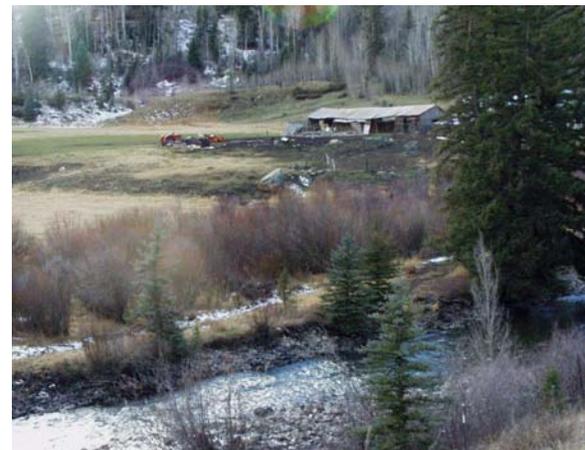
Middle: Land use has altered riparian habitat and resulted in destabilized banks.

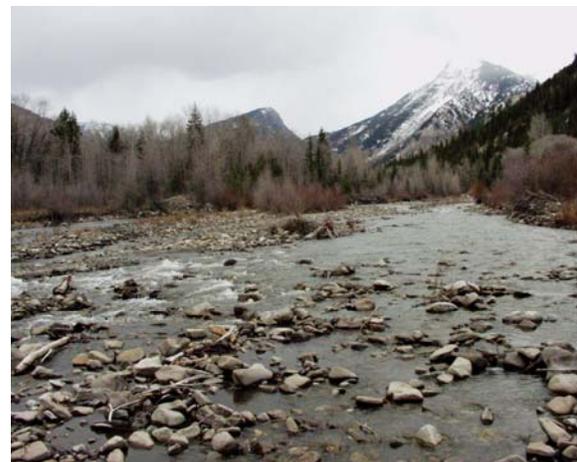
At base flow wildlife habitat is reduced due to channel widening and stream shallowing.

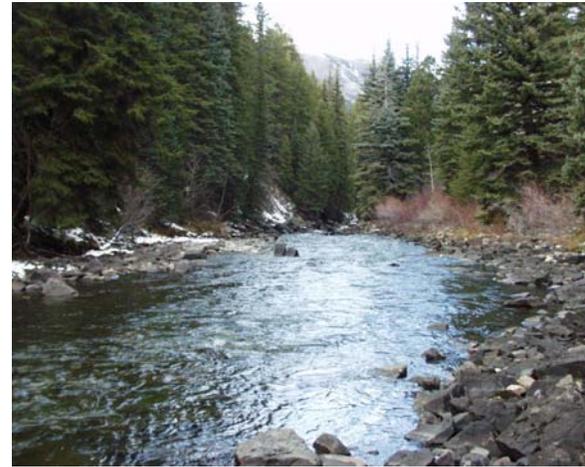
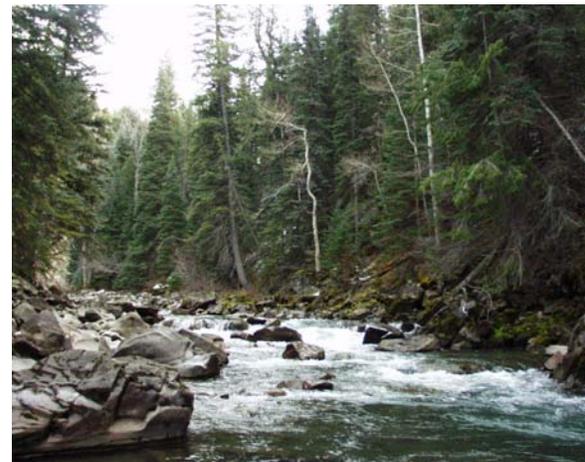
Above: At the top of the reach the stream enters a narrow, steep canyon.
Below: Steep canyon walls are densely vegetated and stable and stream morphology is diverse.

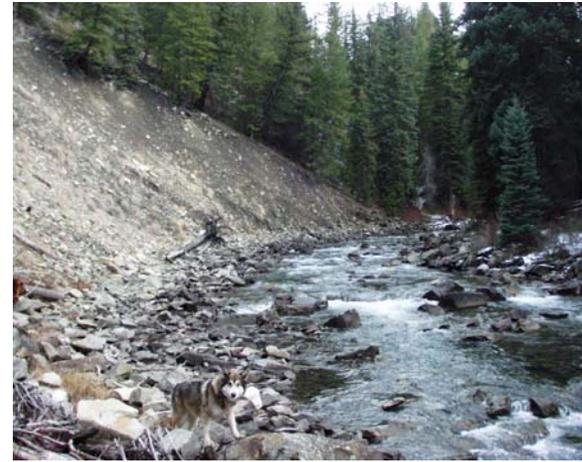
Natural bank instability introduces excess sediment to the stream during spring runoff.

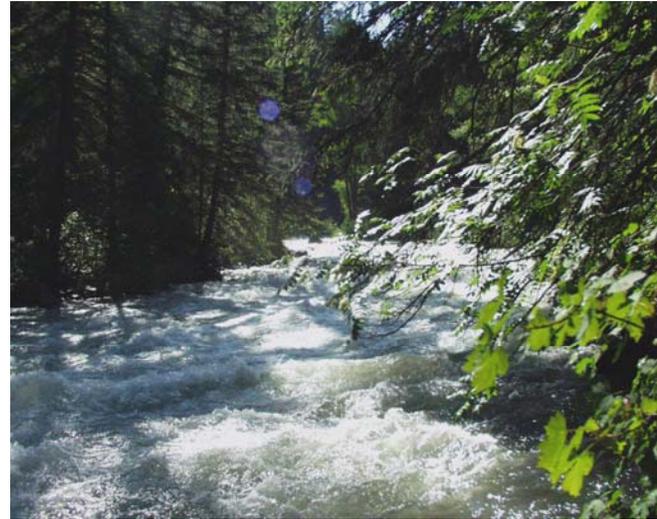
Above: During spring floods, boulders dissipate energy and healthy native vegetation prevents bank erosion.

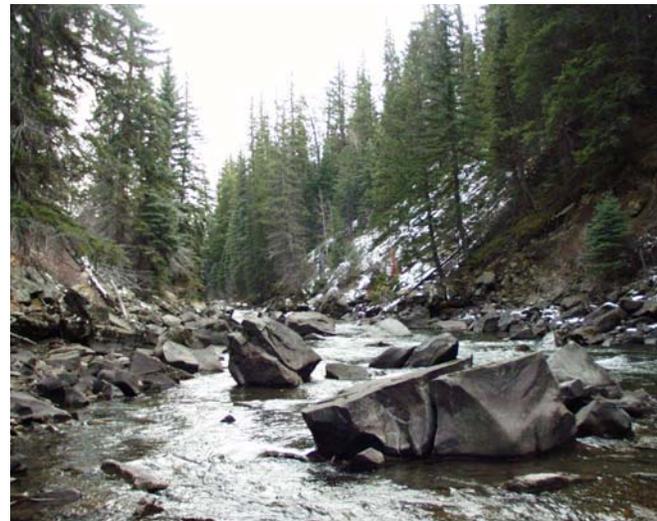
Left: During base flow conditions the pools created by numerous large boulders provide essential deep, slow water habitat.

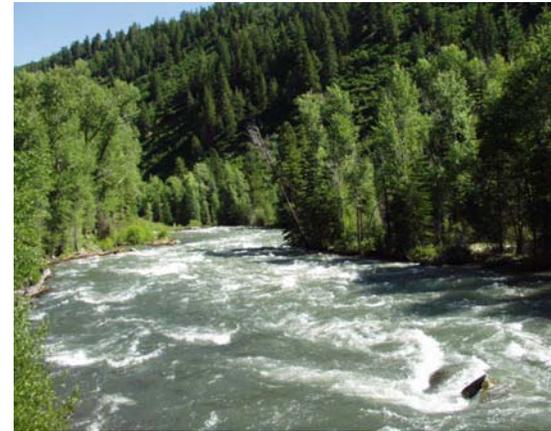
Above: The top of the reach during spring flood – native vegetation stabilizes banks.

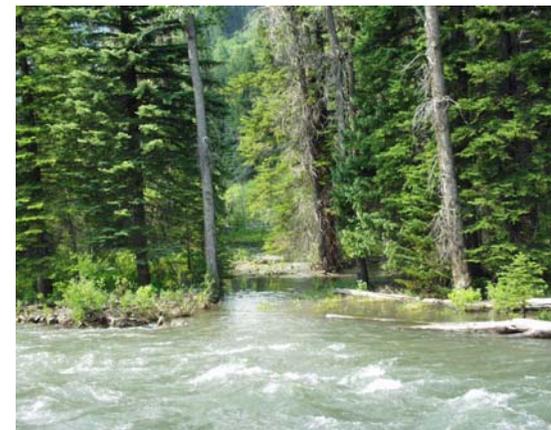
Middle: Overbanking on the right bank during spring flood dissipates energy and recharges ground water.

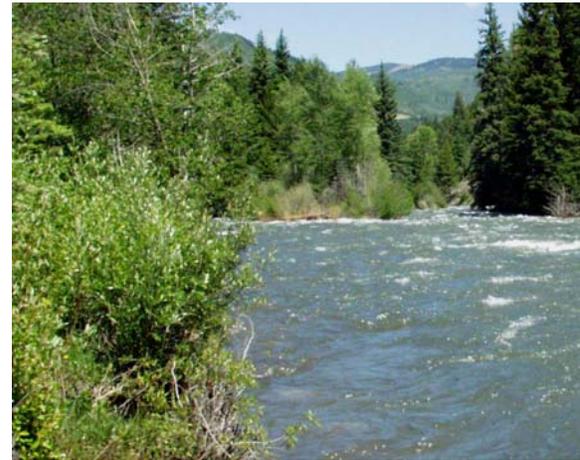
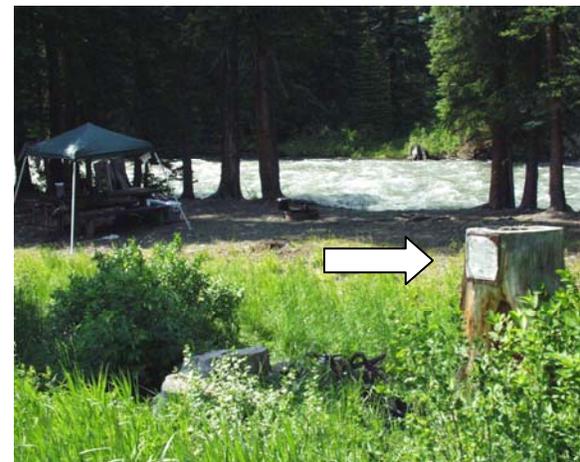
Above: Riparian habitat on most of the upper campground is in excellent condition.
Below: On the lower campground, unmanaged camping and vandalism has destroyed trees and degraded riparian habitat.

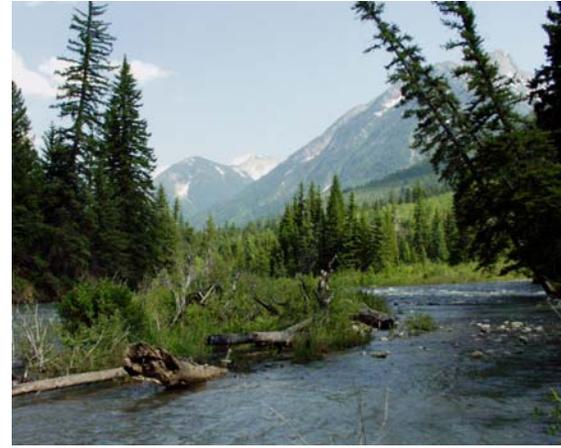
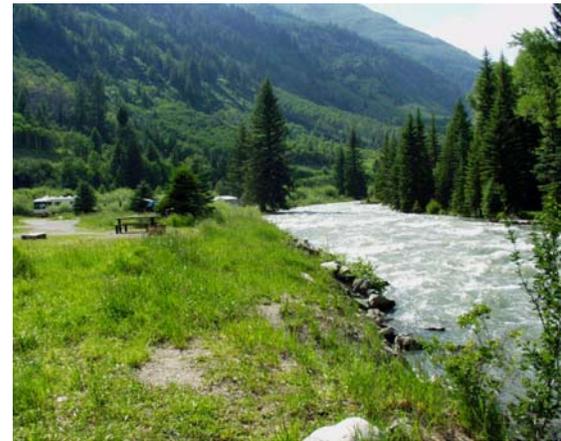
Above: Mid-channel islands improve instream morphologic diversity.
Below: Vegetation removal has resulted in bank erosion and consequent stream straightening and reduced instream diversity.

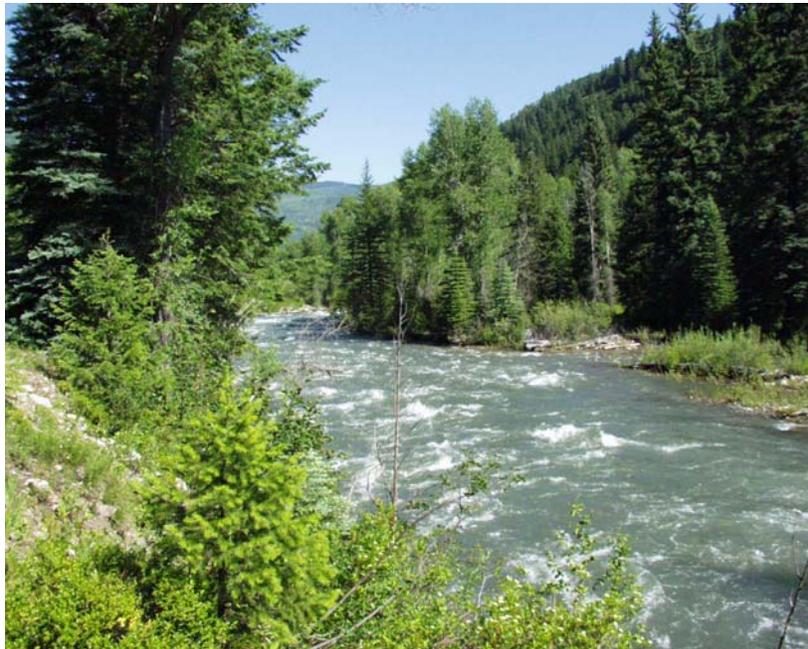
Standing at the top of the reach looking downstream: Diverse and undisturbed habitat on the right bank provides excellent wildlife potential.

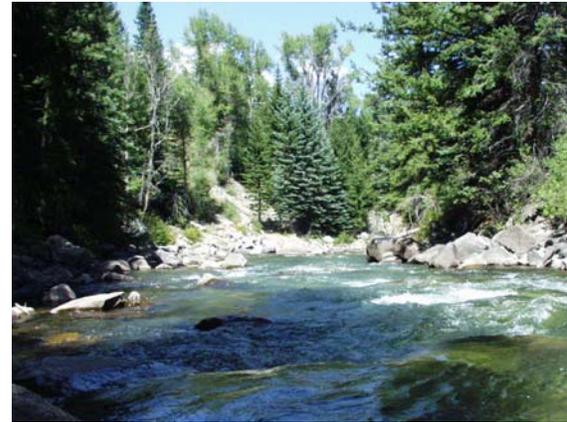
Above: Riparian habitat is in good condition on 30-40% of the reach.

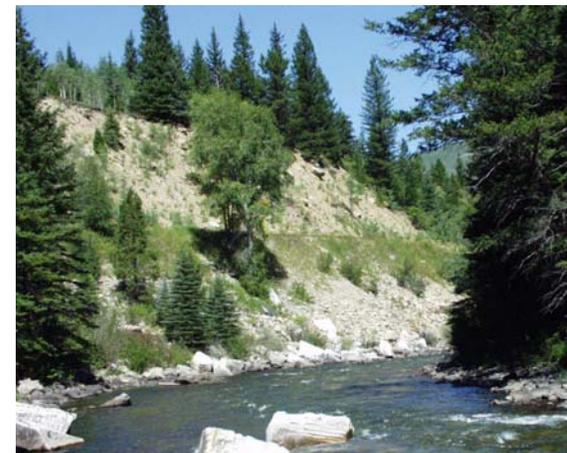
Below: The historic railroad grade and current road cut destroyed riparian vegetation and degrades stream banks.

- Revegetate road cuts with appropriate native vegetation and install sedimentation prevention measures.
- Establish riparian setbacks of at least 50 m that prevent building in the riparian zone or altering riparian vegetation.
- Restore riparian vegetation where lawns and homes encroach into the riparian zone and onto stream banks.
- As indicated by aquatic vegetation, nutrient levels are excessive; determine and mitigate the source(s) of excessive stream nutrients.

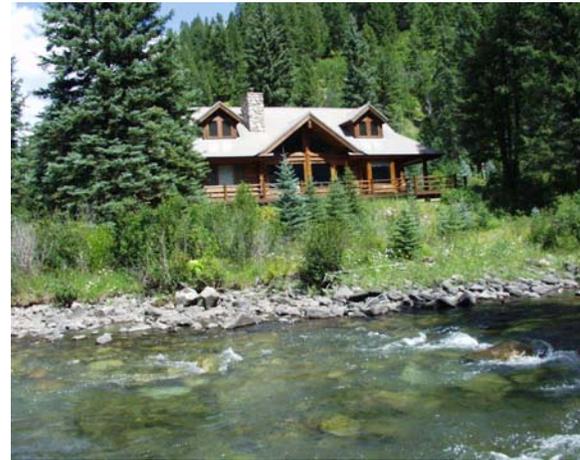
Above: Some homeowners have opted to allow natural vegetation restoration to occur.

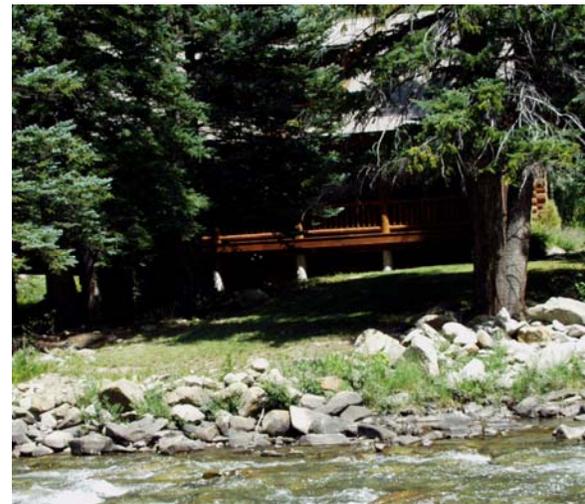
Below: Removal of riparian shrubs and forbs typifies development along this reach and has resulted in bank erosion.

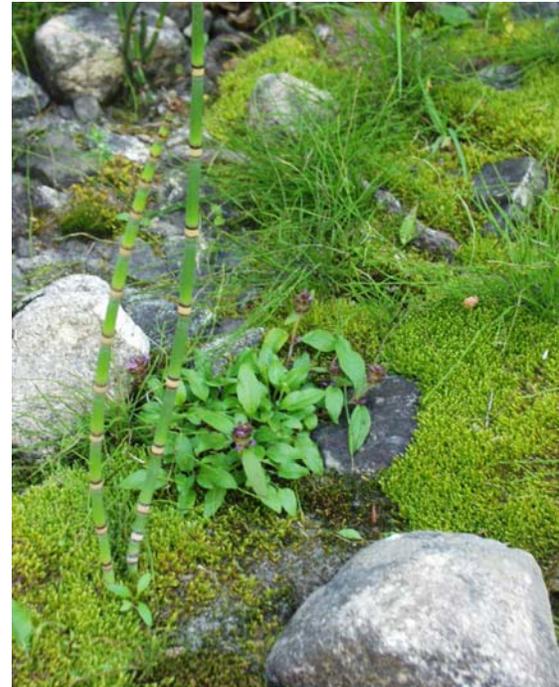
Mosses are important and effective bank stabilizers that are easily destroyed by human trampling.

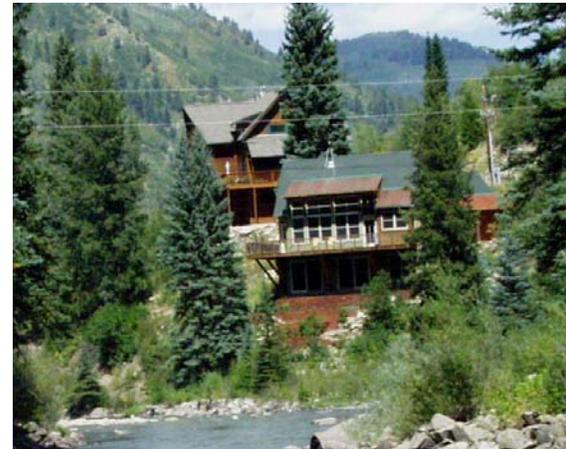
Building in the riparian zone and on the stream bank has reduced riparian functions and degraded stream habitat.

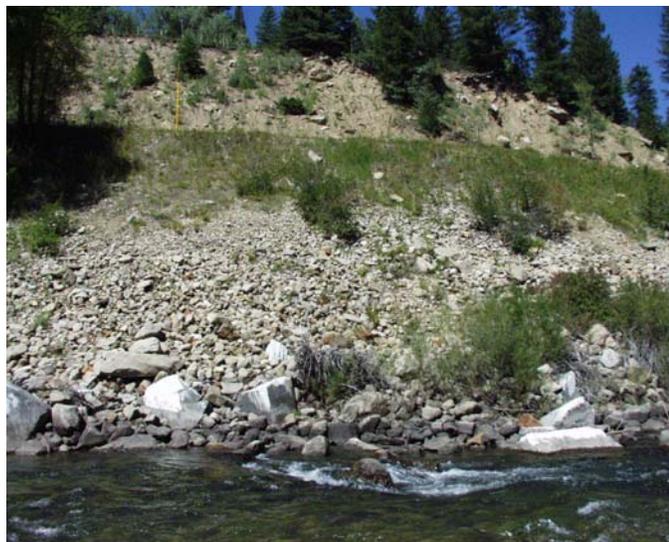
Runoff, laden with road-based pollutants, including sediment, is carried directly into the stream, unfiltered, due to the lack of riparian vegetation.
