# Cattle Creek Stream Health Evaluation

SUBMITTED: 6/7/2016

# Cattle Creek 2015 Stream Health Evaluation

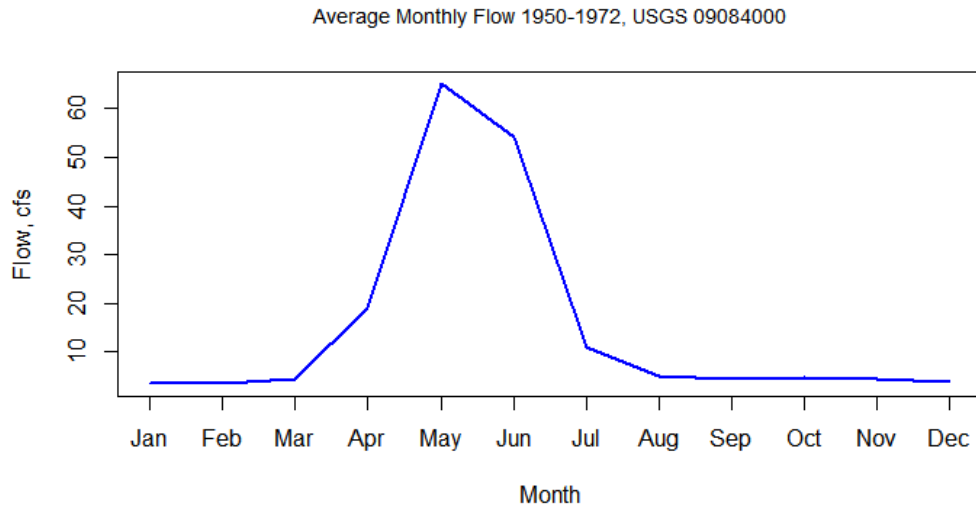
**Figure 1. Annual Hydrograph**

Cattle Creek drains an 88 square mile watershed with elevations ranging from 11,500' in the east on Red Table Mountain to 5,940' at the mouth. The annual hydrologic cycle is snowmelt-driven, with high flows in May-June, limited high flow pulses during the summer monsoon cycle, and low base flows throughout fall and winter. USGS operated a gage at site 09084000 near Bowers Gulch from 1950 to 1972 that characterized seasonal flow patterns and basin yield for the upper half of the watershed (Figure 1). This location is near the USFS boundary, above several important tributaries like Coulter Creek. While it represents the general characteristics of the creek's annual flow regime; it does not represent typical flow conditions or full-watershed yields at the creek's outlet point. Parties interested in more detailed physical, hydrological, or biological information concerning Cattle Creek watershed are encouraged to consult additional local sources such as RFC's 2008 State of the Roaring Fork Watershed (Clarke et. al., 2008) or the Aspen-Sopris Ranger District of the White River National Forest.

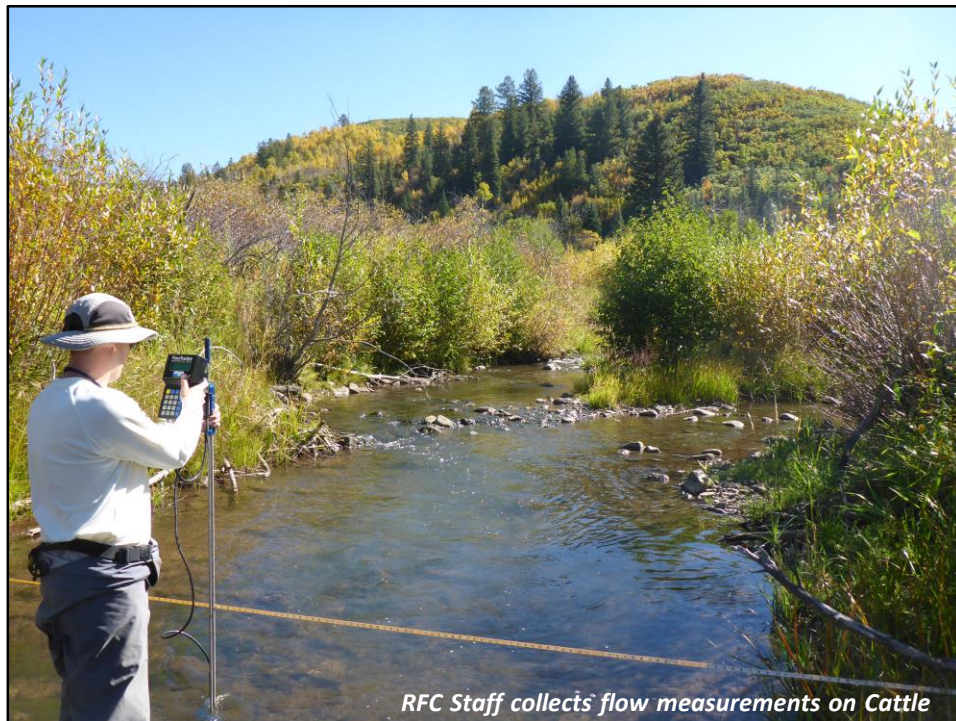
Field personnel measured discharge manually using the velocity-area method described in *USGS Techniques and Methods 3-A8* with a Sontek Flowtracker Handheld Acoustic Doppler velocimeter. RFC collected grab samples using methodologies based on techniques described in *USGS National Field Manual for The Collection of Water-Quality Data*. Containers were labeled with unique IDs, the date, sample location, and time of sample collection, and kept cold in an ice cooler. At the end of each collection day, RFC hand delivered samples to local labs or shipped overnight to labs in refrigerated packaging using chain of custody documentation.

*RFC Staff collects flow measurements on Cattle*

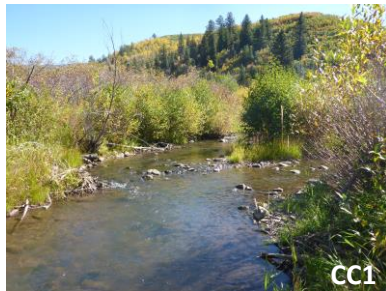
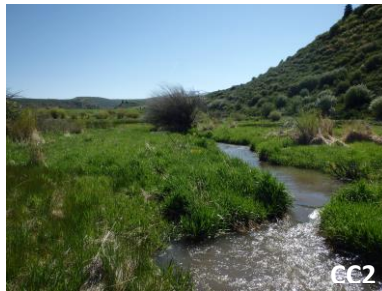
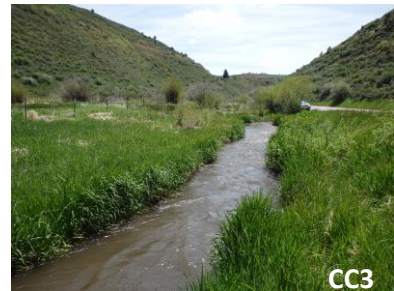
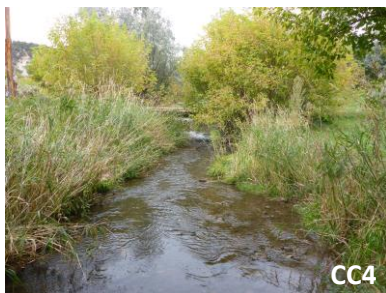
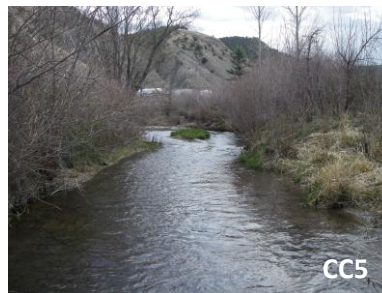
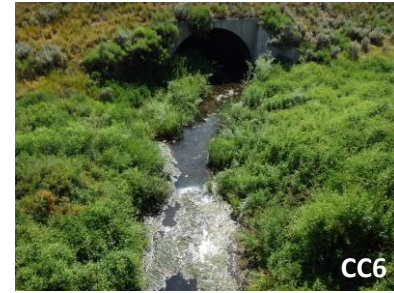
Figure 2. Site location map

Site ID	Description	Purpose	Latitude	Longitude
CC1	Cattle Creek at national forest boundary	Reference/baseline conditions	39.46637	-107.05266
CC2	Cattle Creek above confluence with Coulter Creek	Bracket Coulter Creek, capture upper watershed ranching influences	39.46484	-107.14022
CC3	Cattle Creek below confluence with Coulter Creek	Bracket Coulter Creek influence	39.46414	-107.14080
CC4	Cattle Creek at 1164 Hwy 113	Captures majority of upstream range use and agricultural properties	39.45081	-107.24426
CC5	Cattle Creek above Hwy 82	Bracket commercial/industrial land uses and major road-related impacts	39.45621	-107.26164
CC6	Cattle Creek at Rio Grande Trail Bridge	Bracket Hwy. 82	39.45644	-107.26301
CC7	Cattle Creek above confluence with Roaring Fork	Downstream integration of watershed influences	39.46240	-107.27055

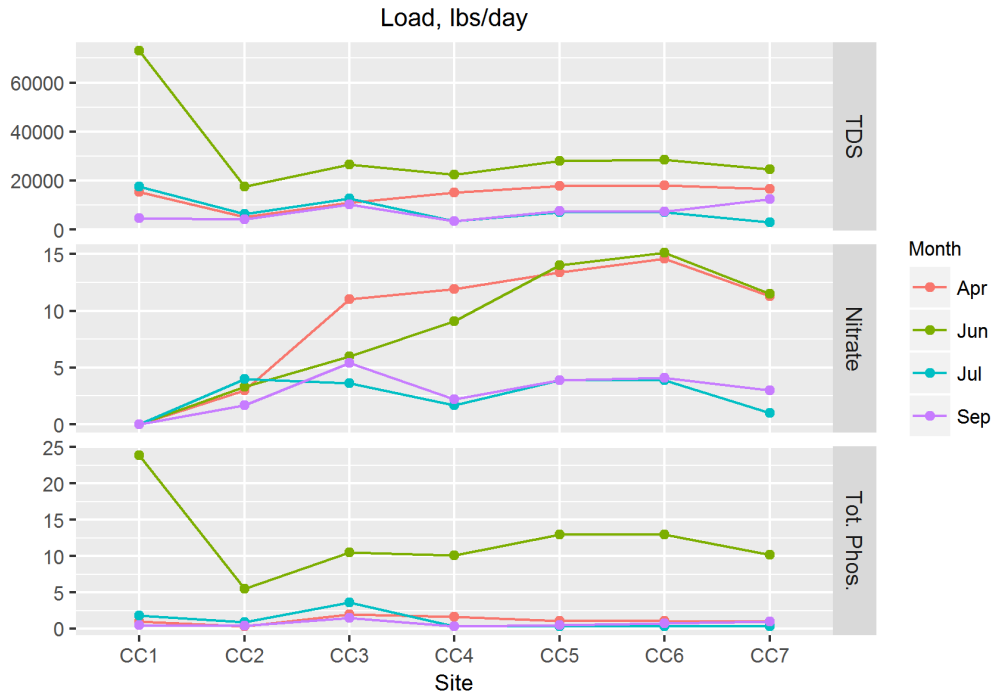
Figure 5. Load Profiles

The highest loading to Cattle Creek for most parameters occurred in June during runoff, when large discharge volumes are capable of carrying more materials overall in solution and suspension. The significant drop between CC1 and CC2 evident in the June profiles is due to the large amount of water diverted between these two sites via the Mountain Meadow, Needham, C and M, Park, and Monarch ditches.

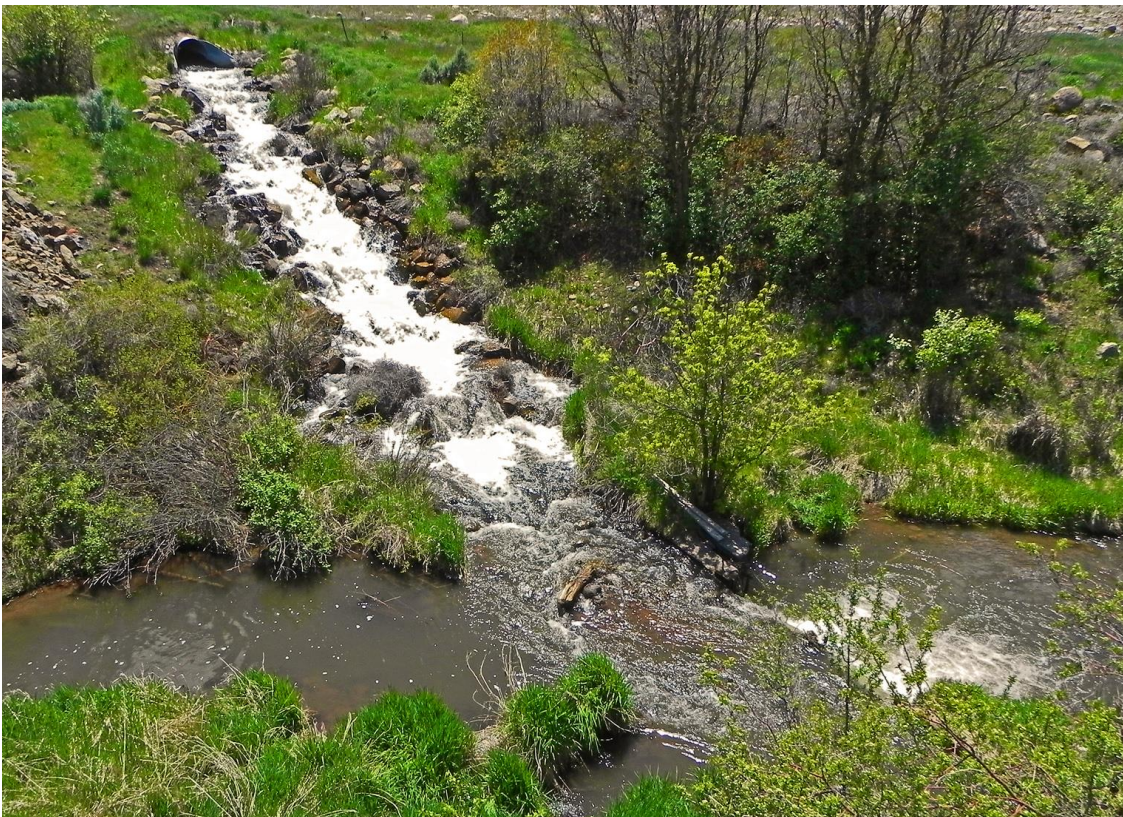
*Glenwood Ditch mixing with Cattle Creek below CC6 Photo: Jack Dysart*

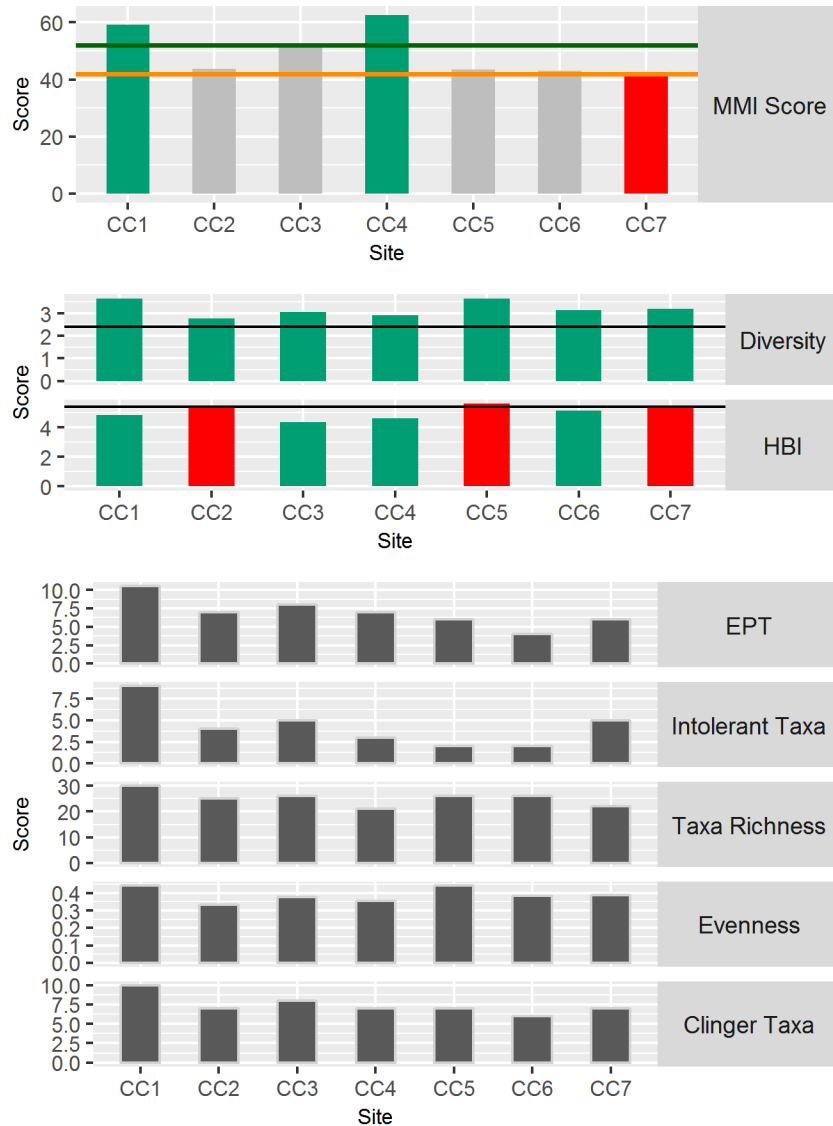
Figure 8. Macroinvertebrate Community Metrics by Site.

All sites in the study area show signs of aquatic life impacts, however disturbances at the lower sites were greater. An overall pattern of increasing stress in the downstream direction is present. The exception at the upper sites (CC1-CC3) is site CC2, which may have lower scores partially explained by the presence of nearby beaver dams and backwater effects. The MMI test is designed primarily to compare representative macroinvertebrate communities in similar riffle habitats. Habitat quality may be an important driver of some of the variability in MMI scores on Cattle Creek. Lower watershed site scores displayed a decrease in the prevalence of both sensitive taxa and specialized taxa (Figure 3, lower panel). Scores at the lower three sites consistently indicate increased stress and disturbance relative to the upper sites.

Top panel: MMI scores with attain/impair lines (green/orange). Middle panel: auxiliary metrics with attain/impair lines; Shannon Diversity scores must be *above* the line, HBI scores must be *below* the line. Lower panel: additional indices. For top two panels, attaining scores are *green*, impaired scores are *red*. The site CC1 score in all panels is the average score of the first sample and replicate sample, both scores attained standards prior averaging.

Cattle Creek MMI scores exhibited a range of variability, with several attaining sites, several impaired, and multiple sites falling initially in the grey zone (Table 11). Scores from the reference site indicated healthy stream communities above the USFS boundary. A decline at the next site showed impacted conditions above Coulter Creek. CC2 scored initially in the grey zone and received impaired status due to the HBI metric, which was slightly above the cutoff at 5.46. Field staff noted the potential for beaver dams and backwater habitat characteristics to influence this site, and the high HBI may indicate some nutrient impacts. Scores rebound below Coulter Creek at CC3 and CC4. After initial grey zone status, auxiliary metric evaluation moved CC5 to impaired status and CC6 to attaining. CC7, at the watershed mouth, scored as impaired without any auxiliary evaluation.
