# South Fork of Dutch Creek Pilot Project Report

*Prepared by:* Sharon Clarke, Roaring Fork Conservancy;  
Justin Anderson, Mark Lacy, Brian McMullen, and John Proctor,  
White River National Forest  
March 26, 2014  
Final September 30, 2016

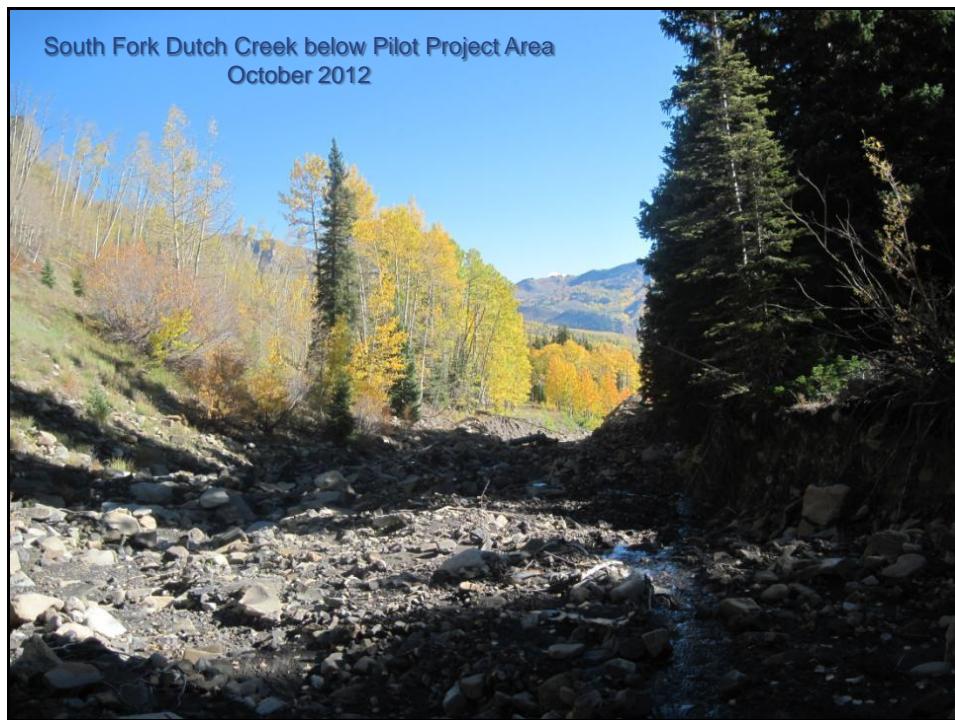
Figure 2. South Fork of Dutch Creek below the pilot project area.

The South Fork of Dutch Creek in Coal Basin ([Figure 2](#)) is a textbook example of an impacted stream - the channel has a high width to depth ratio, lacks riparian vegetation, and fine sediments clog the channel. The 10-acre South Fork of Dutch Creek pilot project was designed as a reclamation project for this severely-impacted area. In addition, the study evaluated costs and benefits of several different restoration techniques in order to determine the most favorable methods to be utilized in the planned landscape-scale restoration of Coal Basin.

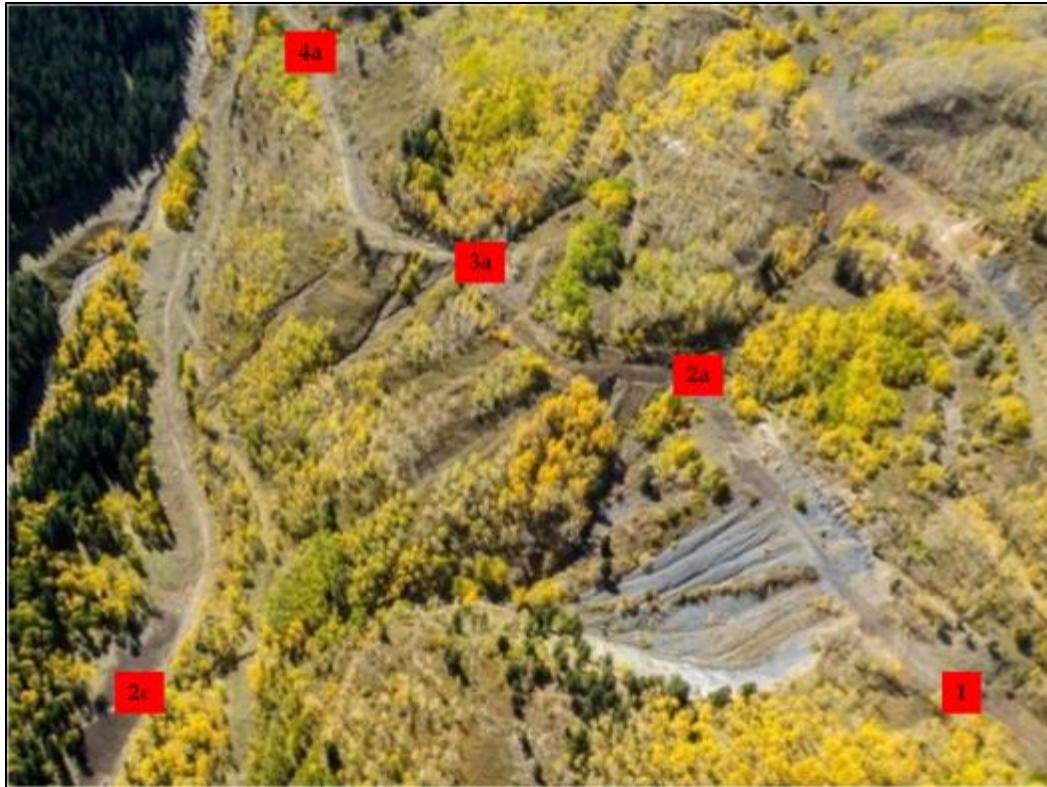
**Figure 5.** Pilot project area with work ongoing, September 2012 (source: EcoFlight). Note the darkened surface at area 2c (“alluvial fan”), where the largest volume of compost/biochar was applied.

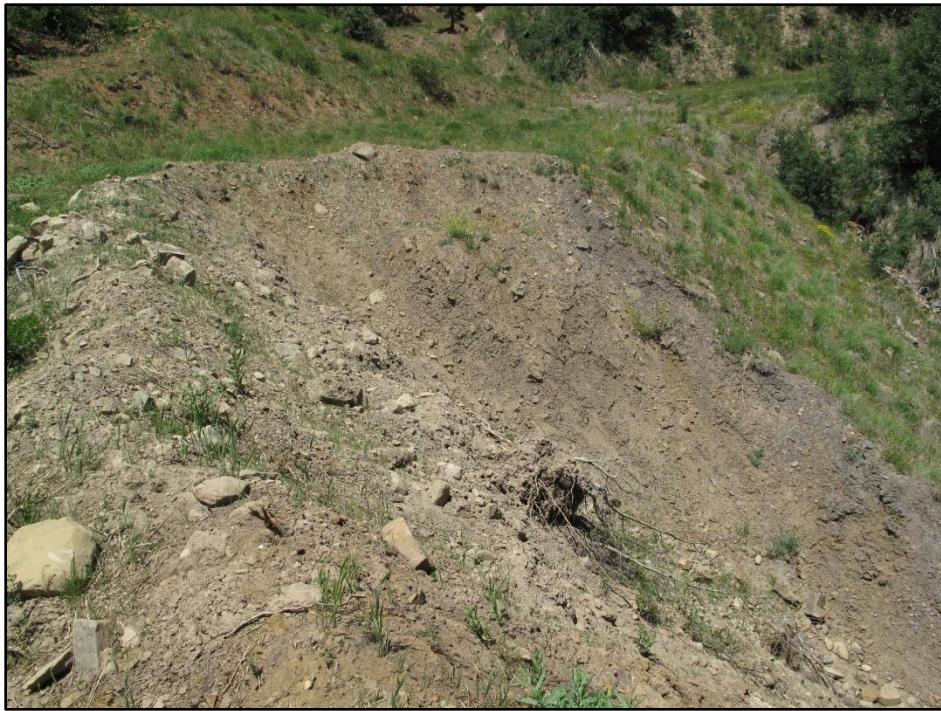
Site 2a in [Figure 6](#) shows an intermittent stream channel failure associated with a road crossing. Some of the water from the channel was routed down the road, causing the formation of gullies, rills and a headcut where water exited the road prism. The area was rehabilitated by reconnecting and hardening the stream crossing, cross ripping the road prism adjacent to the stream channel, placing wood perpendicular to the slope at the head cut, amending the soils with biochar and compost, and seeding the entire area with locally sourced, ecotypic native grasses ([Figure 7](#)).

Figure 6. Area 2a before restoration.

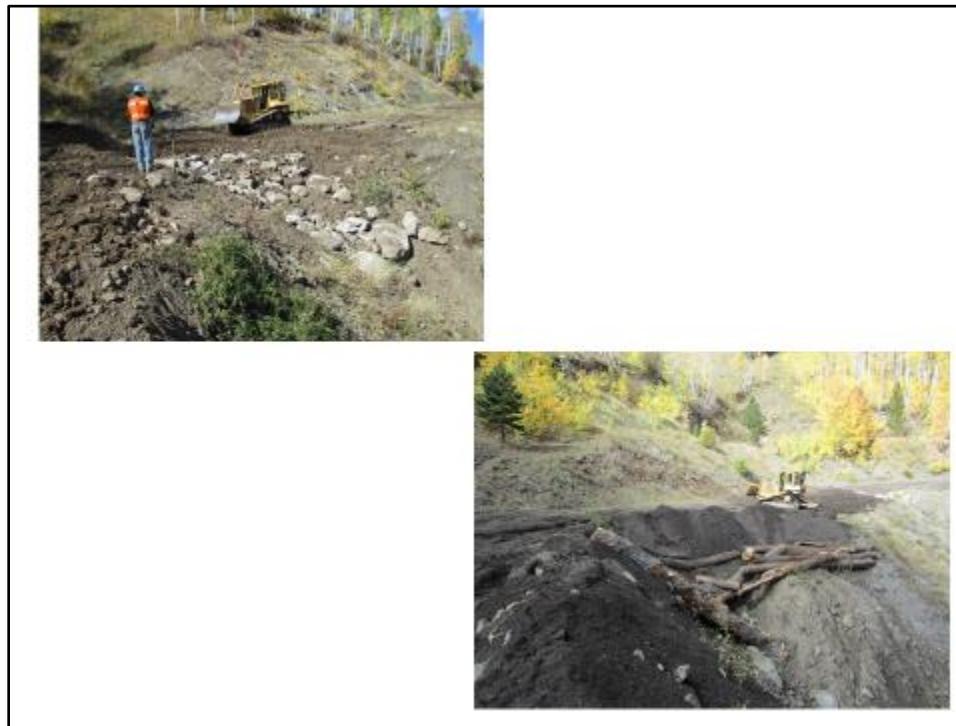
Figure 7. Area 2a during restoration.

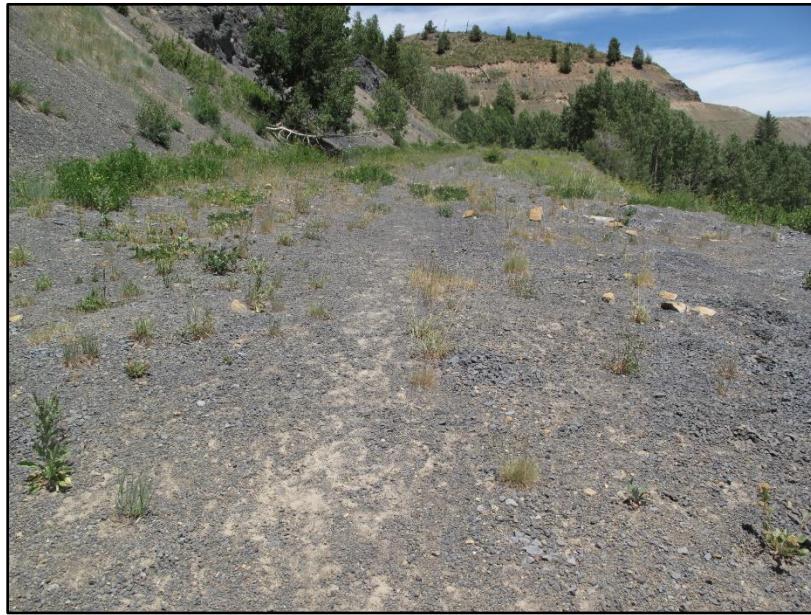
Figures 8 and 9 show the road prism before and after reclamation. In Coal Basin there are approximately 17 miles of legacy mining roads that were built using the cut-and-fill method; these were in-sloped to convey water, which was subsequently routed through culverts under the road. The culverts contributed to channel degradation by increasing flows in channels not naturally designed to carry these flows. Part of the reclamation

**Figure 8. Road prism before treatment; road had minimal infiltration and excessive overland flow.**

work done by CDRMS was to out-slope the road prism and remove the culverts. Additional work still needed to be done on the road prism to improve water routing, increase water infiltration and vegetative cover, and reduce soil losses by sheet flow and rill/gully erosion. To accomplish this, the road prism in the pilot project area was cross-ripped to a depth of 18", water bars were constructed in-between the reconnected intermittent and ephemeral channels, and the entire road prism was broadcast-seeded in the fall of 2012. Selected areas were amended with compost and/or a compost-biochar mixture.

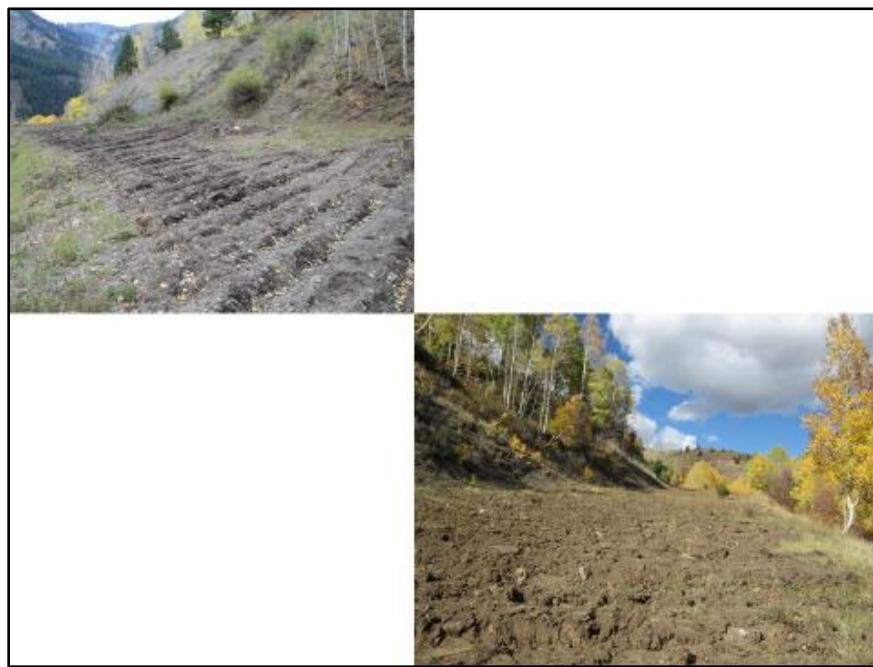
**Figure 9. Cross-ripped road with compost/biochar soil amendment (above) and without soil amendment (below).**

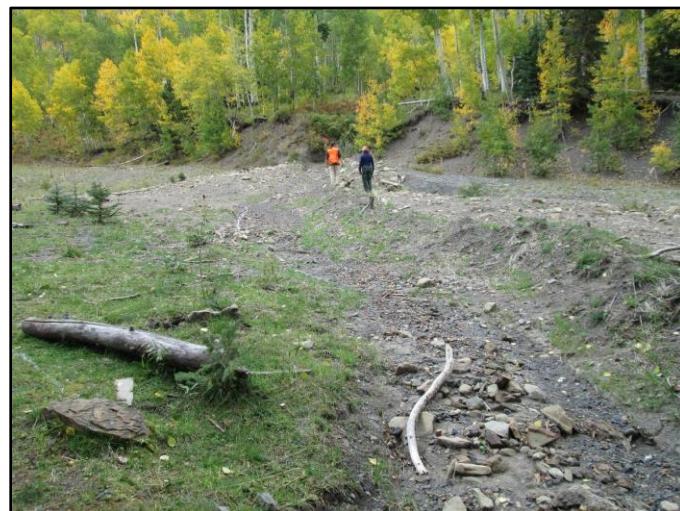
Figure 10. Area 2c alluvial fan before restoration.

Figures 10-13 show the extensive work done on the intermittent stream channel (area 2c), road prism, and floodplain. The primary objective of this effort was to reduce overland flow and sediment delivery to the streams and to provide opportunities for water infiltration and sediment storage in the upland areas, all while increasing vegetative cover. Figure 10 shows the intermittent channel as it drops to the valley floor near the confluence with the South Fork of Dutch Creek. Low gradient areas and associated wide floodplains, exemplified here, are where sediment is naturally stored. To attempt to mimic this natural function, restoration began upslope at site 2a and continued to the confluence area at site 2c. A natural alluvial fan located near the confluence of Braderich and Coal Creeks was used for reference during construction of the alluvial fan shown in Figures 11 and 12. Several things were done as part of this site reclamation: the stream road crossing was stabilized (as discussed above); the road prism was cross-ripped and soil amendments were added; a 1-acre alluvial fan was constructed; grade controls were installed at the downstream end of the fan/intermittent stream channel using logs; and the area was revegetated with a grass seed mix, spruce seedlings, and willow cuttings.

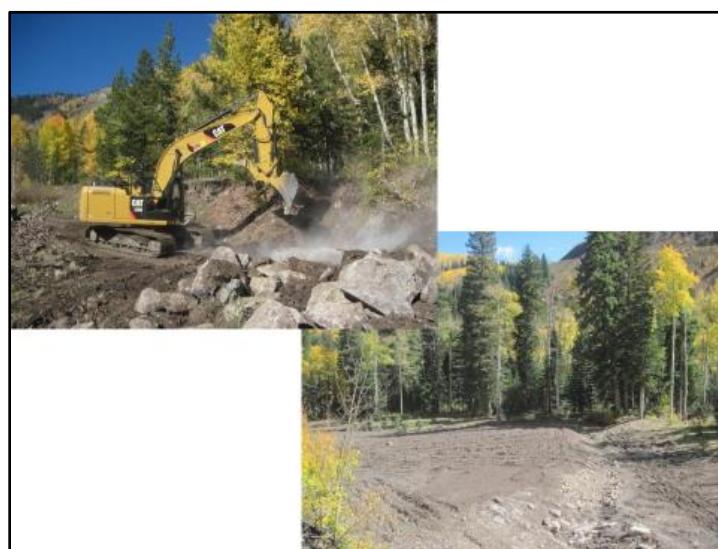
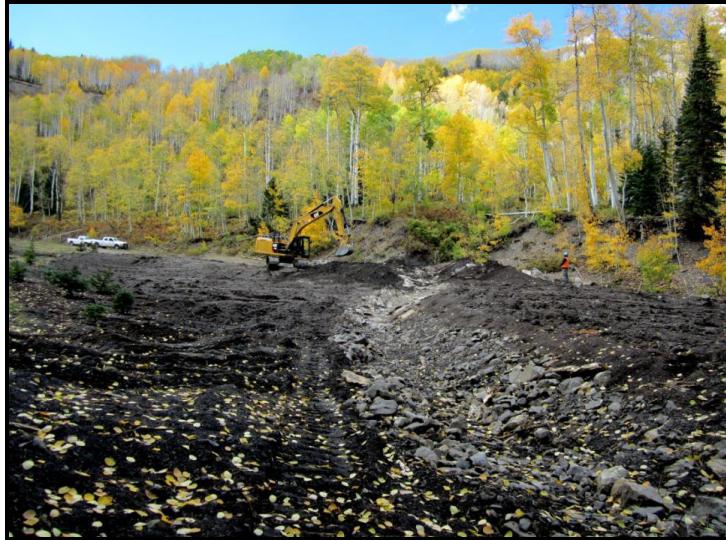
Figure 11. Area 2c alluvial fan during restoration.

Figure 12. Area 2c alluvial fan during restoration.

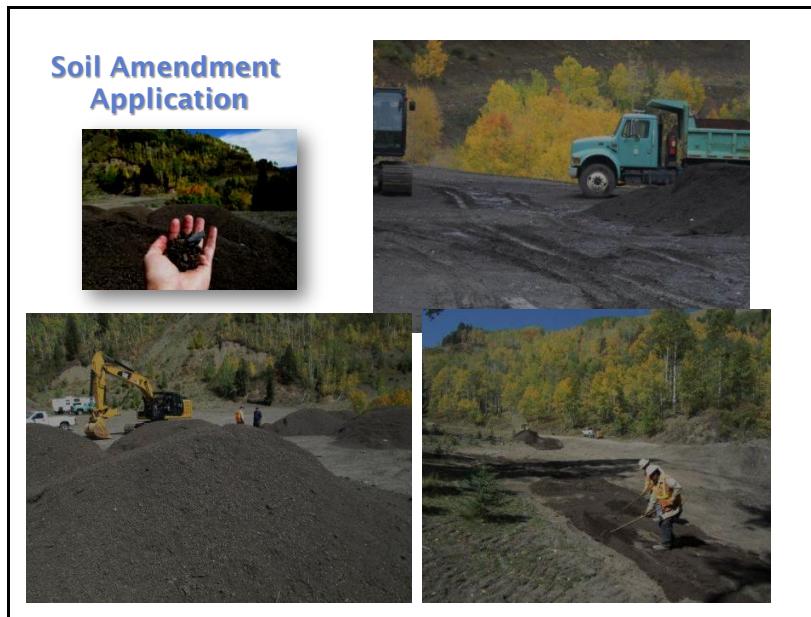
Figure 13. Application of biochar/compost and compost only soil amendments in treatment areas. Top left photo is a close up of biochar. Piles in photos are compost/biochar blend.

Figure 13 shows the application of soil amendments. The purpose of soil amendments is to reduce soil compaction/bulk density, increase soil moisture content, and provide nutrients for plants. Three treatment types were used: a control (no amendments); compost only; and compost with biochar. Compost was obtained from the South Canyon Landfill/Heartland Environmental Services<sup>4</sup> and biochar from Biochar Reclamation, LLC. Table 2 lists the location of the different treatment options.

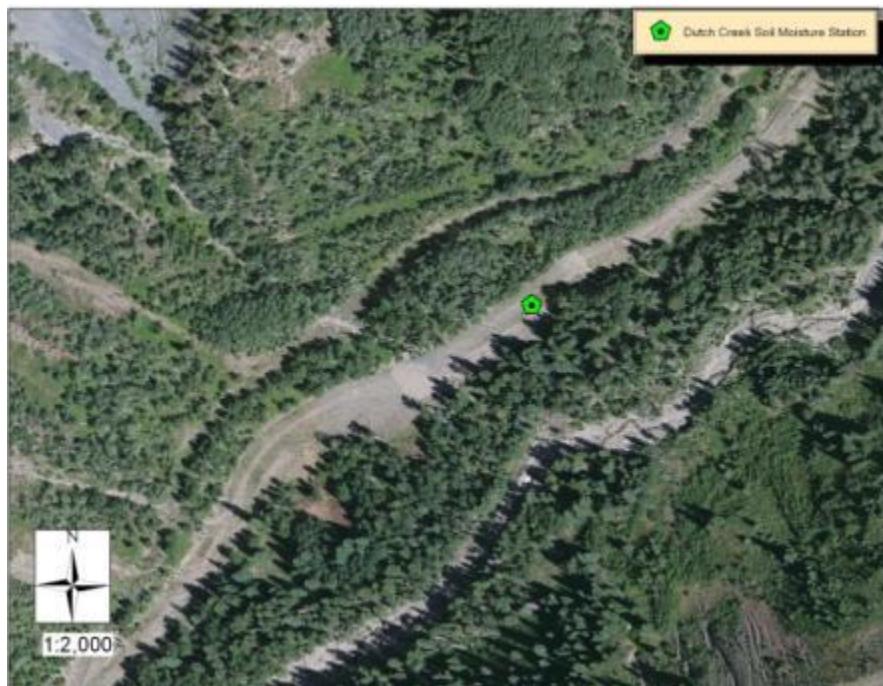
Figure 15. Location of the soil moisture monitoring station in the pilot project area.

Continuous soil monitoring probes were installed at the project site to collect data to facilitate the comparison of the effectiveness of a biochar/compost mix, compost, and no soil amendments for improving soil moisture ([Figures 14](#) and [15](#)). The system consists of a tipping bucket for precipitation data<sup>5</sup>, a photovoltaic panel and battery for solar power, and soil moisture and temperature probes installed within the rooting zone for local vegetation ([Figure 16](#)). Soil moisture probes were located at 2", 8", and 20" depths, following protocols established by Natural Resources Conservation Service (Soil Climate Analysis Network) stations and in a manner compatible with local soil moisture data being collected under the auspices of the Aspen Global Climate Initiative (AGCI). Soil temperature was monitored at the 3" depth for compost with biochar to capture the seed germination zone and the zone of fine roots for grasses. Soil temperature data was not collected for the control or compost only due to equipment limitation. Data was collected from August 21 to November 1, 2013. Data was only collected at the 8" depth (heart of the planting rooting depth) for all three treatments and at the 20" depth for the biochar/compost mix for the two subsequent years: April 15 to November 4, 2014; and March 10 to September 10, 2015. The mean, minimum, and maximum soil moisture content by soil treatment was calculated for comparison among treatments.

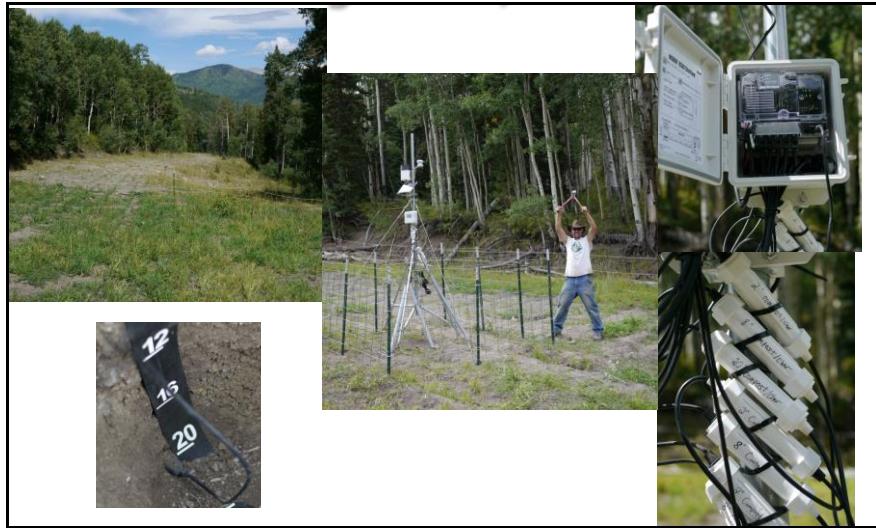
**Figure 16. Soil moisture monitoring station. August 2013.**

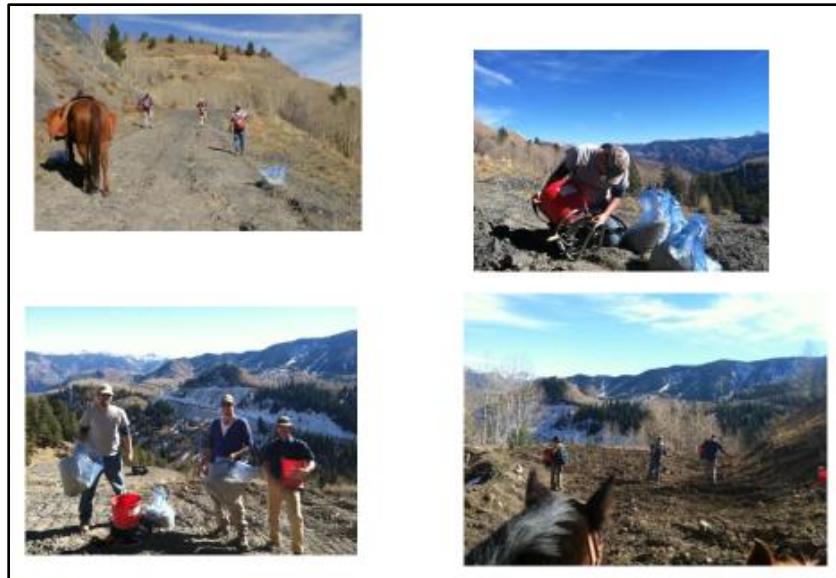
**Figure 17. Seeding with native (ecotypic) WRNF grass seed mix October 31, 2012.**

To improve vegetative cover, and subsequently increase water infiltration and decrease erosion, the treatment areas were seeded and trees were planted. In the fall of 2012, approximately 1.5 miles of road constituting a CDA to the Dutch Creek drainage were ripped and crossed ripped, and then broadcast-seeded at 35 pure live seed (PLS)/acre with a genetically local (ecotypic) grass seed mix ([Figure 17](#)). Individual grass species used in this project are described in the Appendix. The seed mix was comprised of 60% WRNF mountain brome and 40% WRNF slender wheatgrass. Prior to this project, the road had been revegetated with cultivar grasses, including both native and exotic perennial grass species. Additionally, a 1-acre alluvial fan reconstruction area was broadcast-seeded at 35 PLS/acre with a genetically local (ecotypic) grass seed ([Figure 18](#)). The grass seed mix was comprised of 40% WRNF mountain brome, 35% WRNF slender wheatgrass, and 25% WRNF blue wildrye. Prior to seeding, the native soil on this 1-acre site had been amended with 10% biochar/compost.

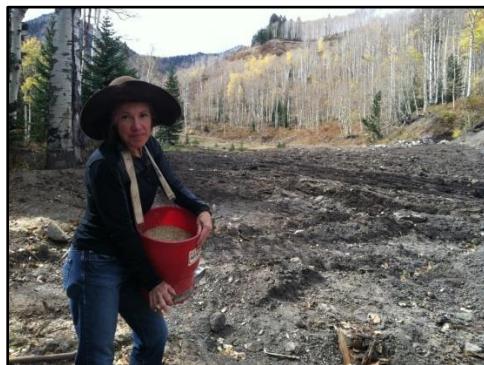
**Figure 18. Reconstructed alluvial fan seeding.**

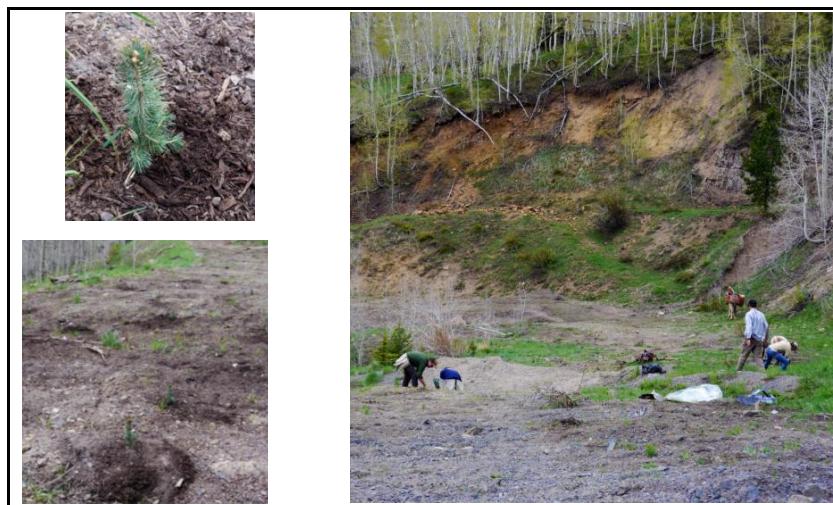
**Figure 19. Engelmann spruce tree planting, June 2013.**

On June 3 and 4, 2013, 750 Engelmann spruce trees (provided by the USFS) were planted by USFS staff with the help of Colorado Parks and Wildlife and the brute strength of “Aspen”, a USFS mule ([Figure 19](#)). Each tree was planted in a hole where the soil was amended to improve conditions at the micro-site level. Planting took place over approximately 4 acres within a 9,000 foot- long decommissioned road prism. Wet draws were planted from the top to the alluvial fan and then down to the gate at the Lamphouse (an abandoned mining facility) in addition to all amended soil locations and other water bars that had visible water. The benefit of using cottonwood’s ability to resprout was incorporated into an onsite project modification. On the newly constructed alluvial fan, green cottonwood logs were buried for three quarters of their length, perpendicular to the slope to provide organic material and future riparian vegetation.

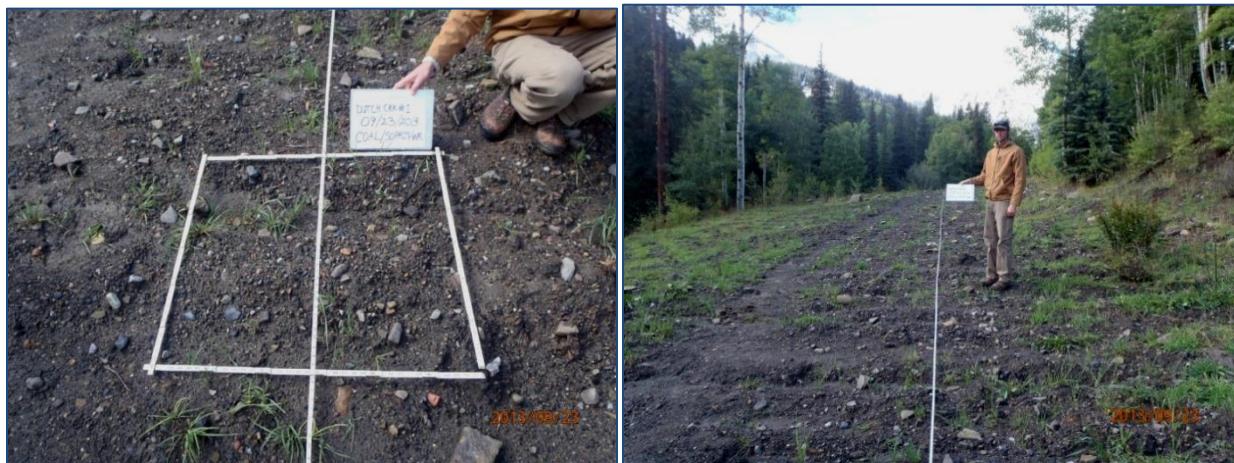
[Figure 20. Dutch Creek transect # 1.](#)

On September 23, 2013 data was collected from one cover frequency transect (Dutch Creek #1-road prism) to determine source performance of the ecotypic seed sources utilized as well as the first year success of that revegetation effort ([Figure 20](#)). Plans to measure two additional transects along this 1.5 mile stretch of road were interrupted by the government furlough. No additional transects associated with the Dutch Creek road decommissioning were measured in 2013. Data were also collected from one cover frequency transect (Dutch Creek #2-alluvial fan) to determine performance of the seed sources utilized in relation to the soil amendments, and to determine the overall success of the revegetation effort. For comparison purposes, we had planned to record cover frequency data from the soil treatments to determine: a) vegetative success among soils amended with compost, b) vegetative success among soils amended with compost/biochar, and c) vegetative success where soils were not amended. We were not able to record data among soils amended with compost only also due to the furlough.

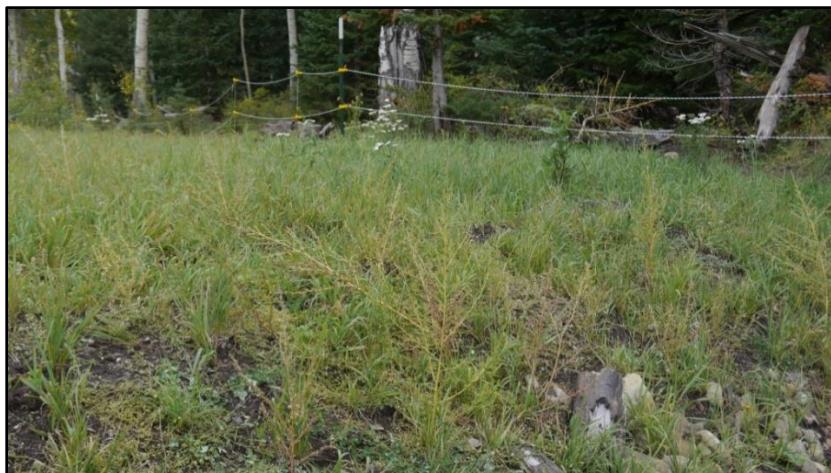
[Figure 21. Electric fence in alluvial fan area.](#)

To protect the vegetation in the project area from cattle grazing, an electric fence was installed by USFS personnel in 2013, 2014, and 2015 (area 2c only). The fence was put up in the spring before cattle were turned out in the USFS grazing allotments ([Figure 21](#)). Mules and horses were used to haul fencing material to the project site. This fence was taken down each fall after the cattle were removed and stored for the winter.

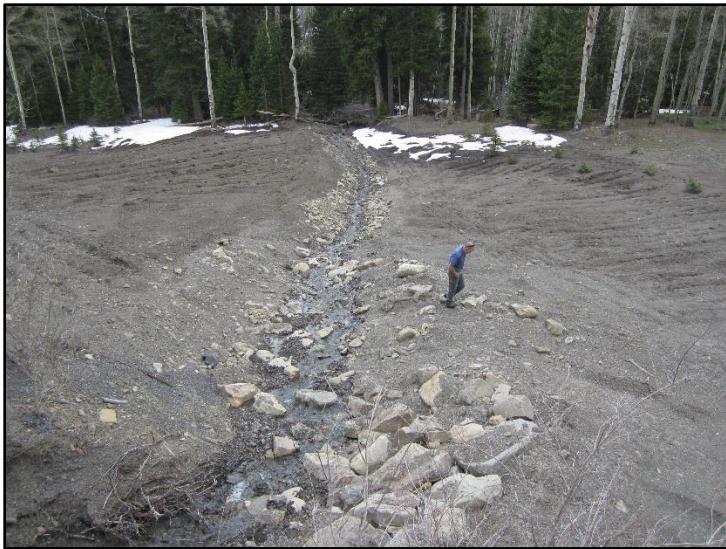
Figure 23. Area 2c alluvial fan transporting water and dissipating sediment (May 13, 2013).

Extensive site modification was conducted to disconnect some of the most disturbed areas on the South Fork of Dutch Creek from the stream channel. In the upper part of the project area where an intermittent channel crossed the road the area was rehabilitated by reconnecting and hardening the stream crossing, cross ripping the road prism adjacent to the stream channel, and placing wood perpendicular to the slope at the head cut. An alluvial fan was constructed at the lower end of this channel. [Figure 23](#), taken after the work was completed shows the alluvial fan transporting water and dissipating sediment. As a continuation of CDRMS work, the entire road prism in the pilot project area was cross-ripped and water bars were constructed in-between the reconnected intermittent and ephemeral channels improving water routing and infiltration, and reducing soil losses by sheet flow and rill/gully erosion. Amending the soil, revegetating with a grass seed mix, spruce seedlings, and willow cuttings followed by treatment for weeds fostered vegetation growth on the modified sites ([Figures 24 and 25](#)).

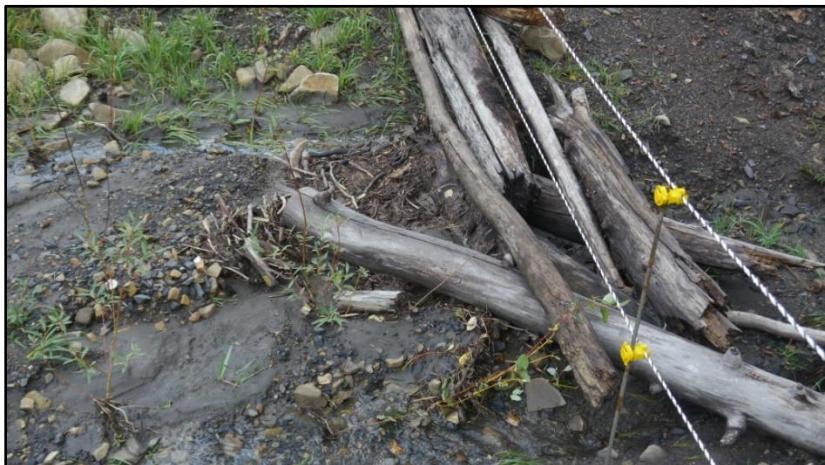
Figure 24. Willow cuttings.

Figure 25. Revegetation of the alluvial fan following restoration (Sept 24, 2013).

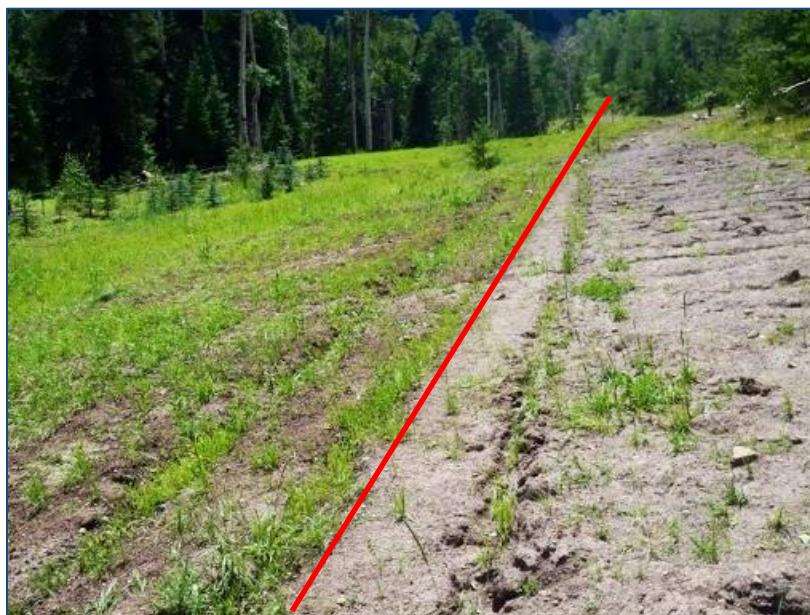
[Figure 34. Contrast between alluvial fan area amended with compost-biochar \(left of red line\) and without \(control-right of red line\). September 24, 2013.](#)

The soil amendments were the key to the successful revegetation of this 1-acre alluvial fan reconstruction site ([Table 6](#) and [Figure 34](#)). Prior to seeding, the native soil had been amended with a 10% biochar/compost mix. The revegetation site experienced good spring and monsoonal moisture, but endured an extended warm and dry period from late May through mid-July. [Figures 35 to 37](#) show the revegetation progression from May through July. The water-holding capacity of the compost and biochar were critical in maintaining soil moisture and water availability to the establishing seedlings during the long dry period. The planting medium allowed the seedlings to obtain optimal root development and ultimately to establish and persist. The compost and biochar also provided nutrients (in the compost) and the ability to retain them (in the biochar), fertilizing the emergent vegetation and increasing the short- and long-term fertility of the growth medium.

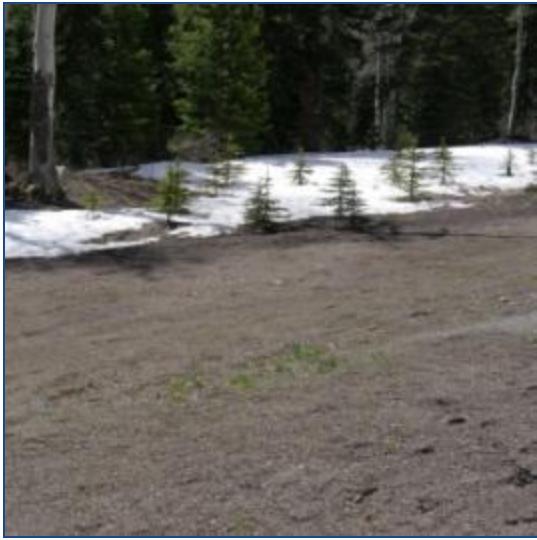
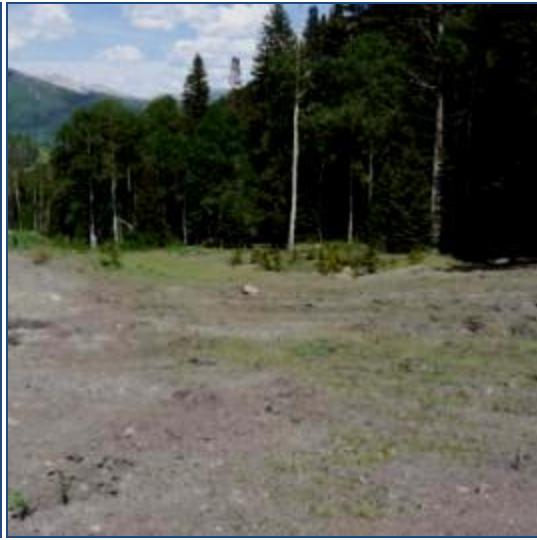
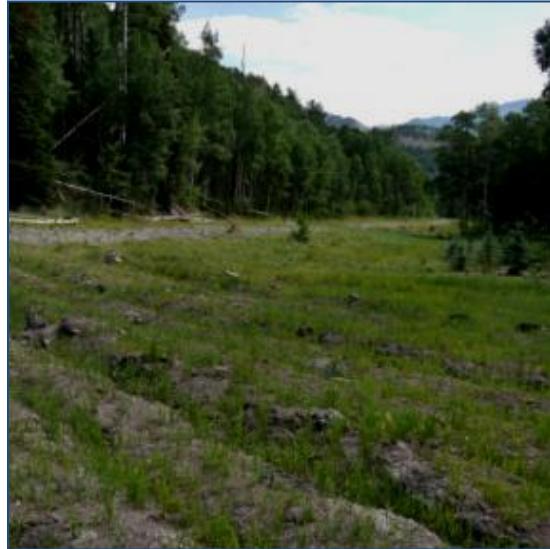
Figure 35. Alluvial fan. May 13, 2013.

Figure 36. Alluvial fan. June 10, 2013.

Figure 37. Alluvial fan. July 10, 2013.
