CRYSTAL RIVER, SEGMENT 1

Beaver Lake above Marble to the Base of McClure Pass

6.13.1 Crystal River Segment 1

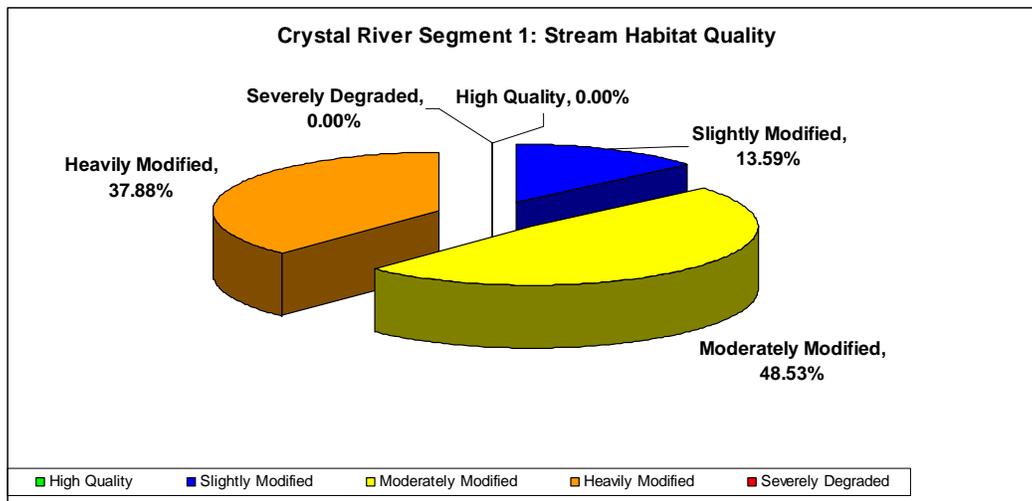
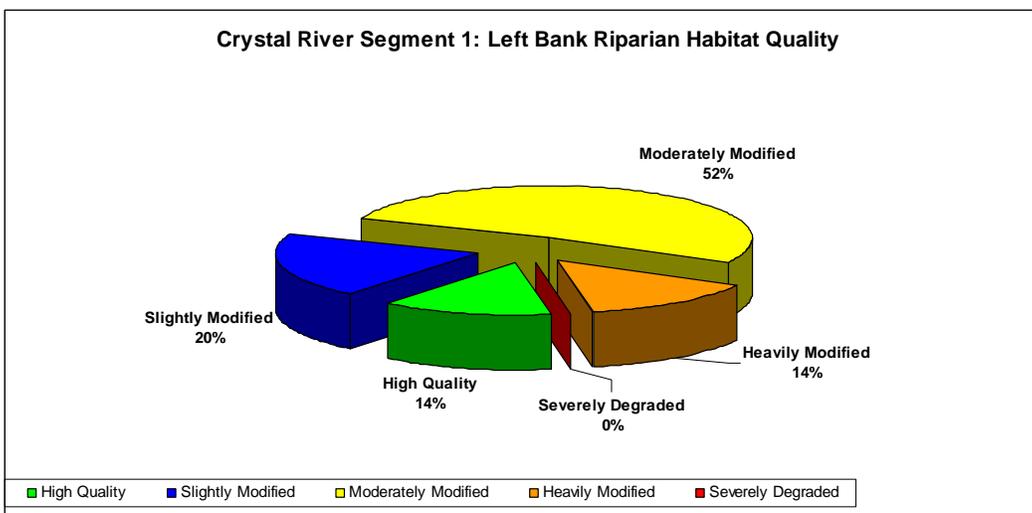
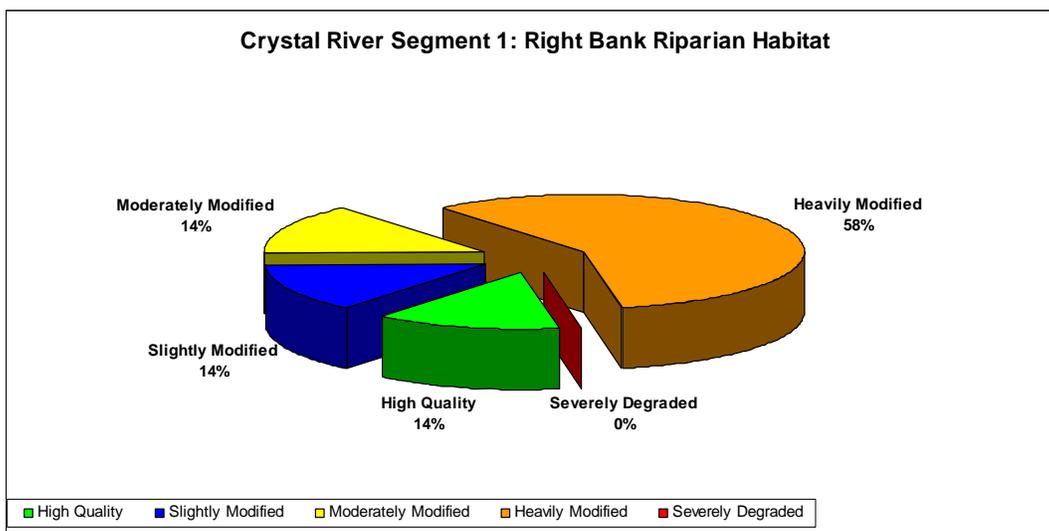
Segment 1, Crystal River: Stream habitat assessment results.
 See appendix for habitat parameters and ranking criteria.

Stream Habitat Parameters	CRI-1 N39 04.092 W107 10.691	CRI-2 N39 04.221 W107 12.041	CRI-3 N39 05.118 W107 14.536	CRI-4 N39 05.654 W107 15.197	CRI-5 N39 06.255 W107 15.812
1. Epifaunal Substrate/Cover (0-20)	15	12	18	15	15
2a. Embeddedness (0-20)	14	14	18	17	18
2b. Pool Substrate Characteristics (0-20)	NA	NA	NA	NA	NA
3a. Velocity/Depth Regime (0-20)	18	15	16	16	16
3b. Pool Variability (0-20)	NA	NA	NA	NA	NA
4. Sediment Deposition (0-20)	13	14	6	15	16
5. Channel Flow Status (0-20)	15	15	16	17	16
6. Channel Alteration (0-20)	13	12	17	15	15
7a. Riffle Frequency (0-20)	17	15	18	16	18
7b. Channel Sinuosity (0-20)	NA	NA	NA	NA	NA
8. Bank Stability (LB: 0-10/RB: 0-10)	8/4	5/3	9/7	5/9	6/5
9. Bank Veg. Protection (LB: 0-10/RB: 0-10)	9/3	5/3	9/8	5/9	5/5
10. Riparian Zone Width (LB: 0-10/RB: 0-10)	9/3	4/4	9/9	5/10	5/5
Reach Total	141	122	161	153	145
Habitat Condition	MM	HM	SM	MM	MM

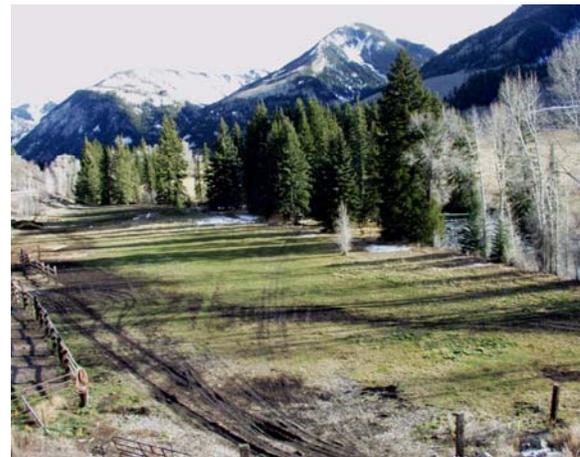
Above: The riparian zone has been cleared and replaced with a grass landing strip.

Middle: Road-based gravel and sediment washes directly into the stream

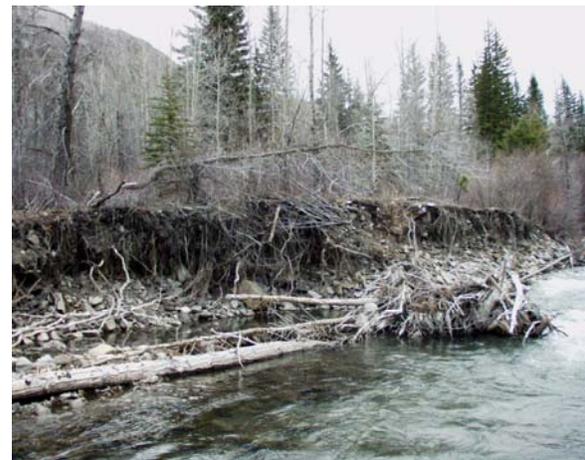
Above: The stream is widening, shallowing and braiding due to bank instability.

Middle: Land use has altered riparian habitat and resulted in destabilized banks.

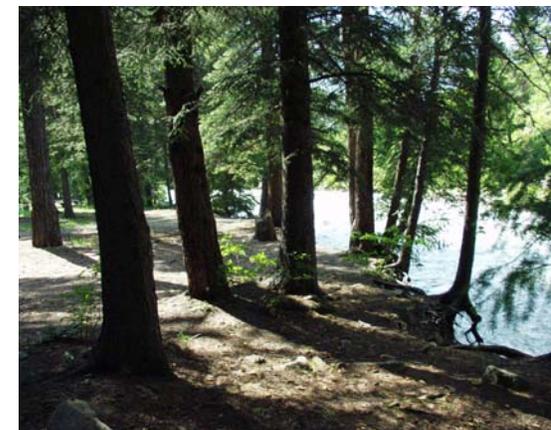
Above: The top of the reach during spring flood – native vegetation stabilizes banks.

Middle: Overbanking on the right bank during spring flood dissipates energy and recharges ground water.

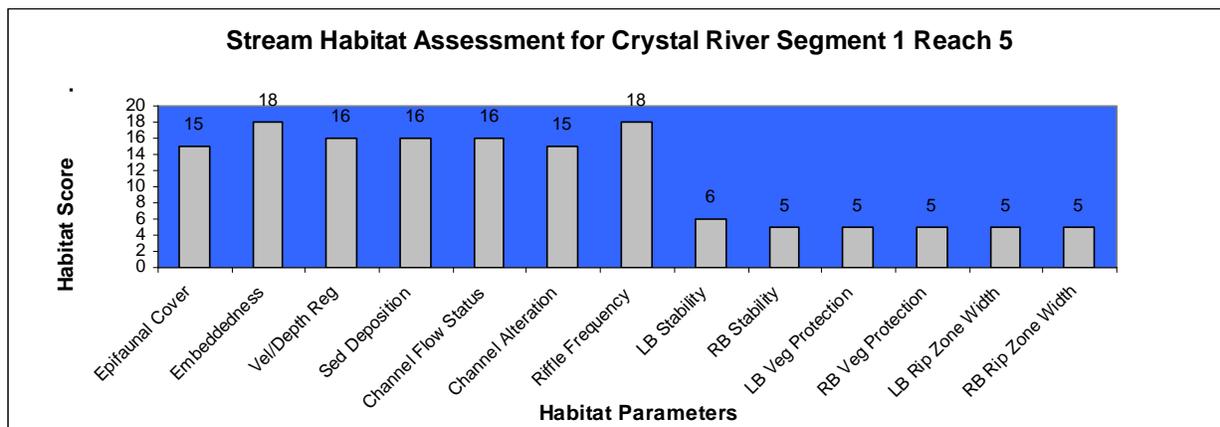
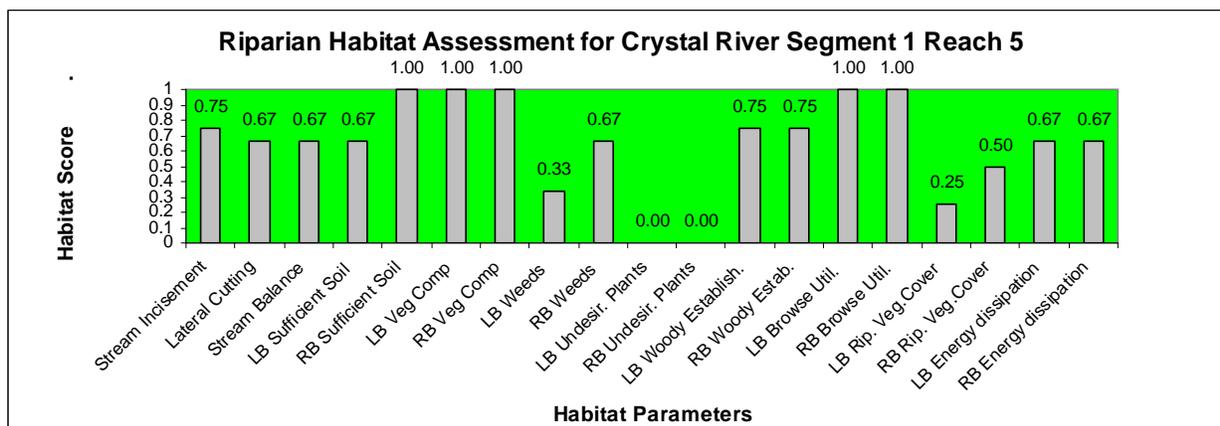
Runoff, laden with road-based pollutants, including sediment, is carried directly into the stream, unfiltered, due to the lack of riparian vegetation.
